MINISTRY OF TRANSPORT

RAILWAY ACCIDENTS

**REPORT ON THE FIRE**  
which occurred in  
an Express Passenger Train  
on 14th July 1951 near  
**HUNTINGDON**  
in the  
**EASTERN REGION**  
**BRITISH RAILWAYS**

10th March, 1952.

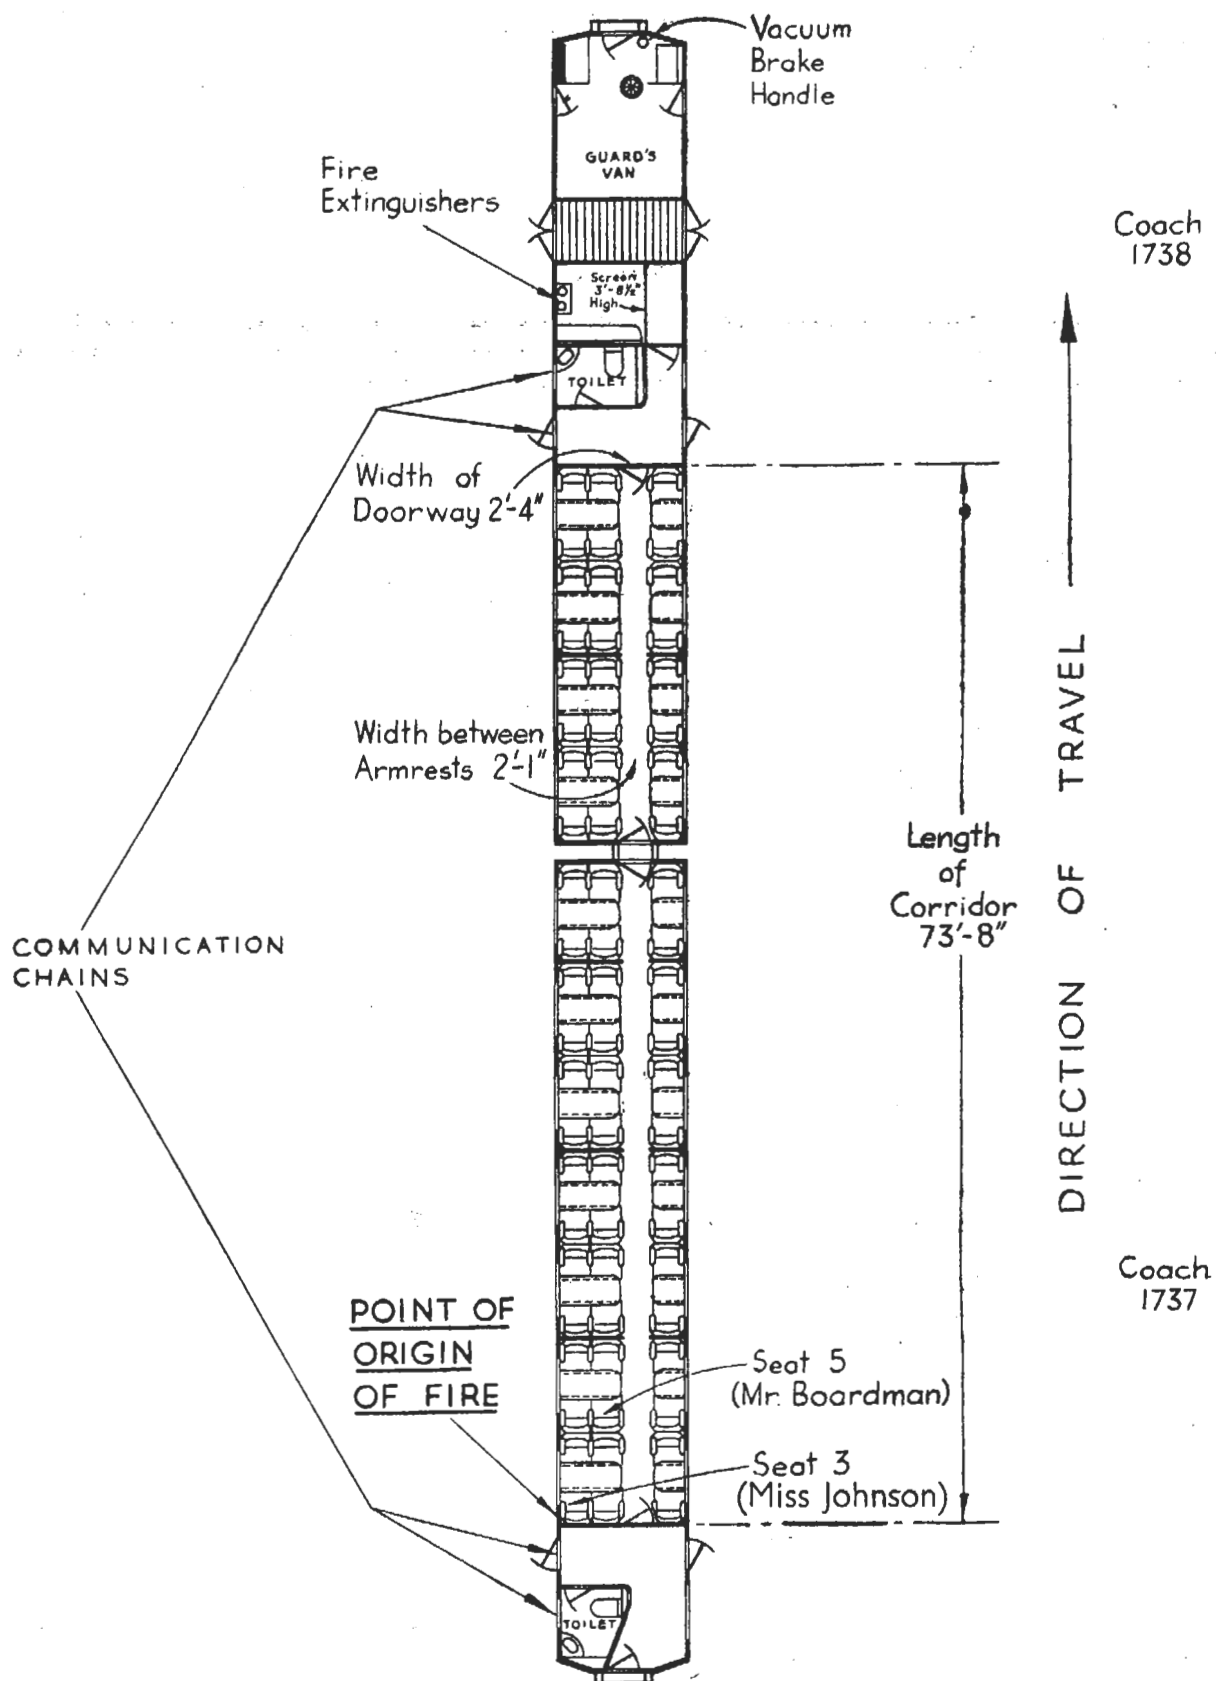
TWIN OPEN THIRD BRAKE SET

A plan of the leading set, including the second coach, No. 1737, in which the fire started, is given under:—

37. This situation was avoidable, for it was caused almost entirely by the general design of the coaches, and by the lack of adequate means of exit. As will be seen in the diagram on page 2, the only two doors by which the designed number of 66 passengers could leave the set were separated by a long narrow corridor, measuring 73 feet 8 inches in length and 2 feet 1 inch in width between armrests of seats. In the centre of the set, where the two coaches were joined, there was another door in each which served only to divide the corridor into two, and to shut off the gangway between coaches. All four doors in the corridor opened inwards, so that a press of people trying to get out might make them impossible to open, as has been known to happen with disastrous results in other fires. The series of openings along the centre of the coaches, through the transverse partitions, greatly increased the impression of length in the corridor, and a passenger sitting in one of the cubicles formed by the partitions, might well feel cut off in an emergency.
