# **Metals in America's Historic Buildings**

Uses and Preservation Treatments

## **Part I. A Historical Survey of Metals**

## **Part II. Deterioration and Methods of Preserving Metals**

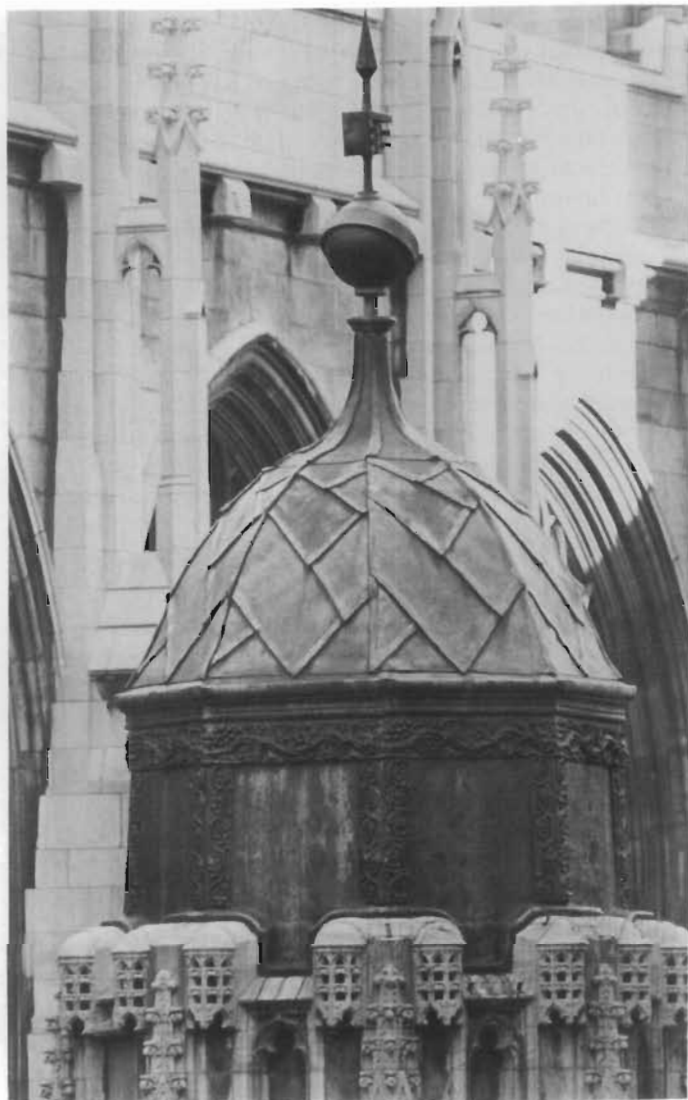
**Figure 6.** Lead Roofing, Saint Thomas Church, Fifth Avenue and 53rd Street, New York City, 1909–1914; Cram, Goodhue, and Ferguson, architects; Henry Hope and Sons, lead craftsman. Ralph Adams Cram designed St. Thomas Church using the spirit and many of the techniques of medieval builders, including the use of small overlapping sheets of lead for roofing curved surfaces. The decorative grapevine frieze and panel borders, also of lead, show the versatility of this material, which can be cast with sharp detail. (Becket Logan)

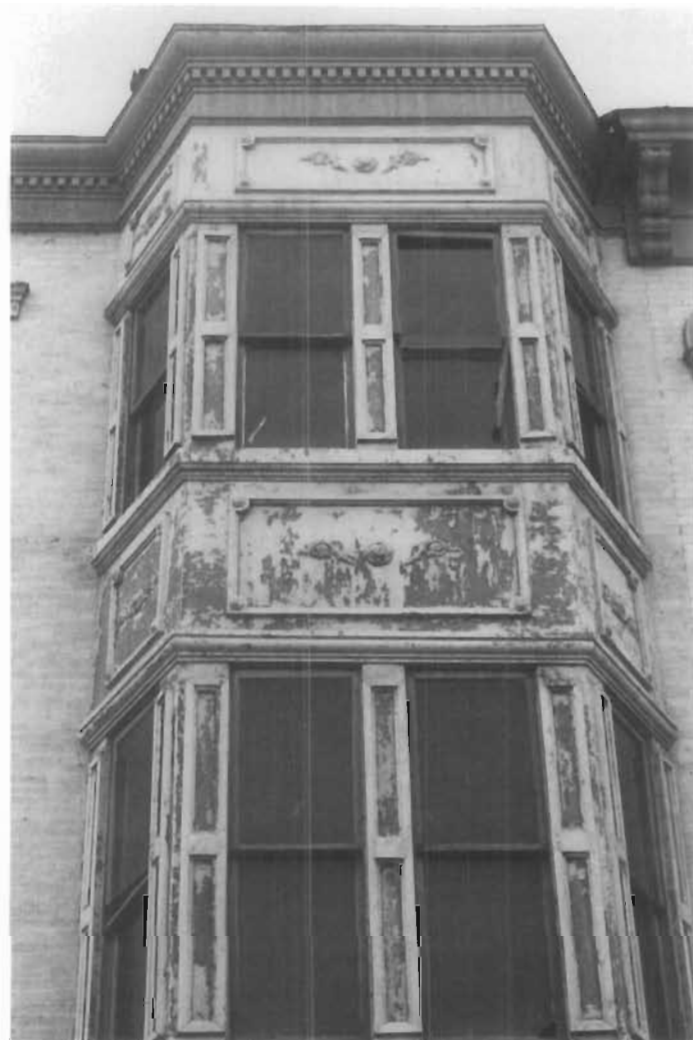
Figure 18. Galvanized Sheet Iron Bay with Applied Zinc Ornament, 608 Indiana Avenue, NW, Washington D.C. When sheet metal work is kept well painted, it is very difficult to identify it as sheet iron or steel, galvanized or tinplated. However, if the metal is not maintained, its composition becomes more obvious. Paint does not adhere well to pure zinc, or to galvanized iron or steel. When the paint peels, it usually comes off completely, including the primer, to reveal a clean metal surface. If the metal is galvanized, it will have a spangled appearance and may show some rust or rust stains from the iron base metal. If it is cast or pressed zinc, it will have a grayish-white appearance. This bay is covered with galvanized sheet iron with pure zinc ornaments on the surface. Even if well painted, a magnet test will reveal what is galvanized iron or steel (which is magnetic) and what is pure zinc (which is non-magnetic). (David W. Look)

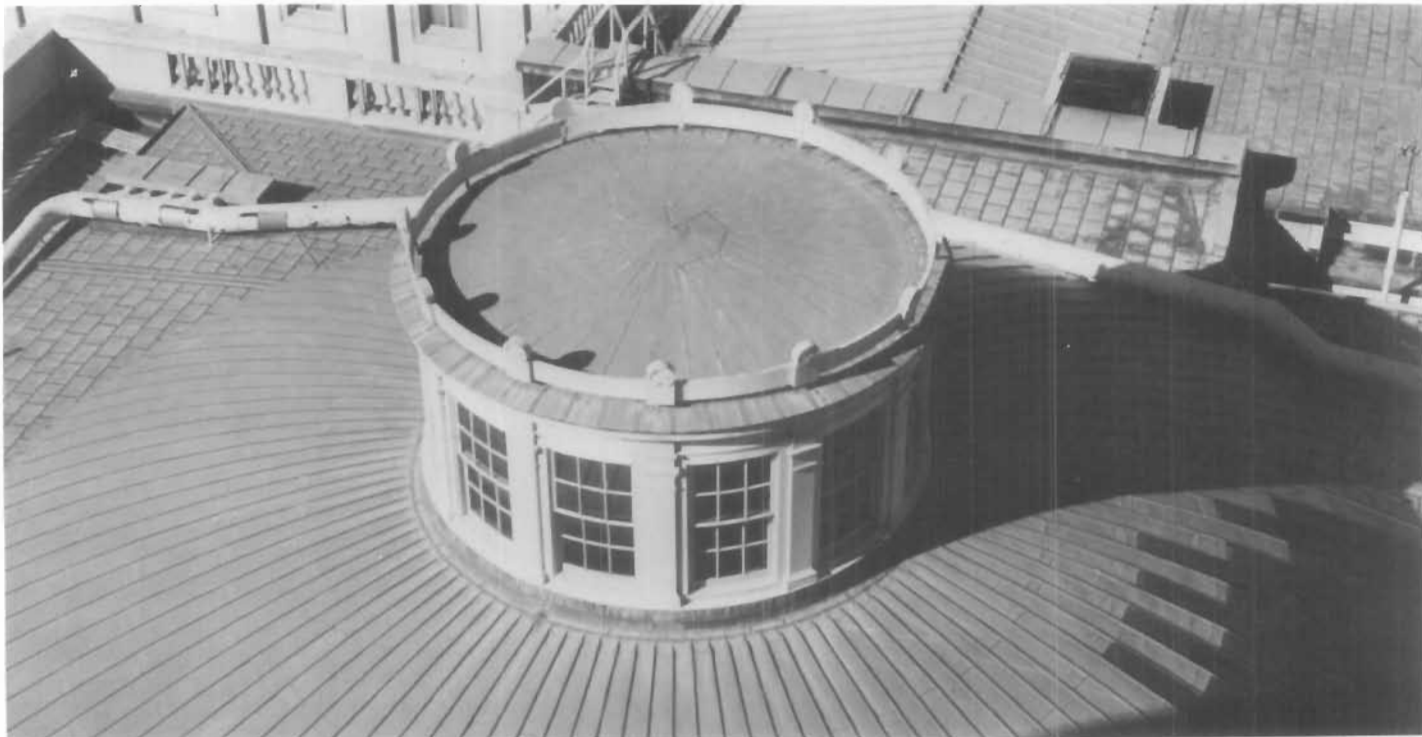
Figure 19. Copper Roof, Old Senate Chamber, United States Capitol, 1819; Benjamin H. Labrobe, architect. After the British burned the Capitol in 1814, the entire structure was rebuilt, including a new copper roof. Little is known about the roofing installed in 1819 since it was removed in 1900. It was probably all flat seams because the machine for forming standing seam roofing was not invented until about the time of the Civil War. When the surfaces were reroofed in 1975, every effort was made to duplicate the 1900 roofing patterns, configuration, and size of sheets. Sheet copper can be shaped to cover many types of curved surfaces. The dome has standing seams while the cupola and the area around the dome, which is flatter, have flat seams. (Charles Parrott)

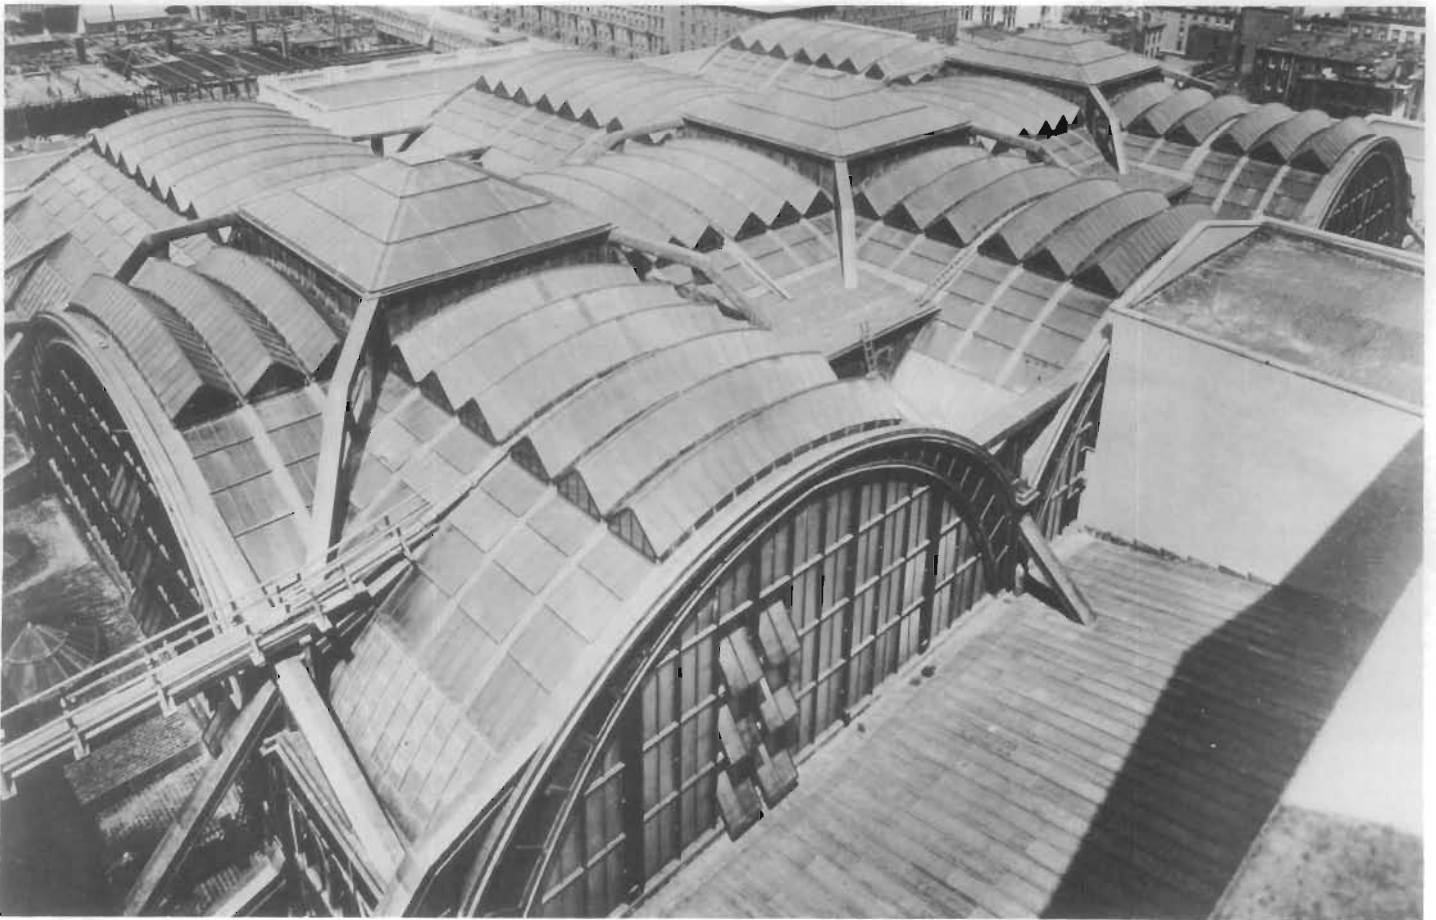
**Figure 47.** Monel Roof, Pennsylvania Railroad Terminal, New York City, 1907-1910; McKim, Mead and White, architects; International Nickel Company. The first architectural use of Monel metal was the sheet roofing of the Pennsylvania Station, which was completed in 1909. When the station was demolished in 1965, the Monel roof was in excellent condition, having needed no major repairs since its installation. (International Nickel Company)

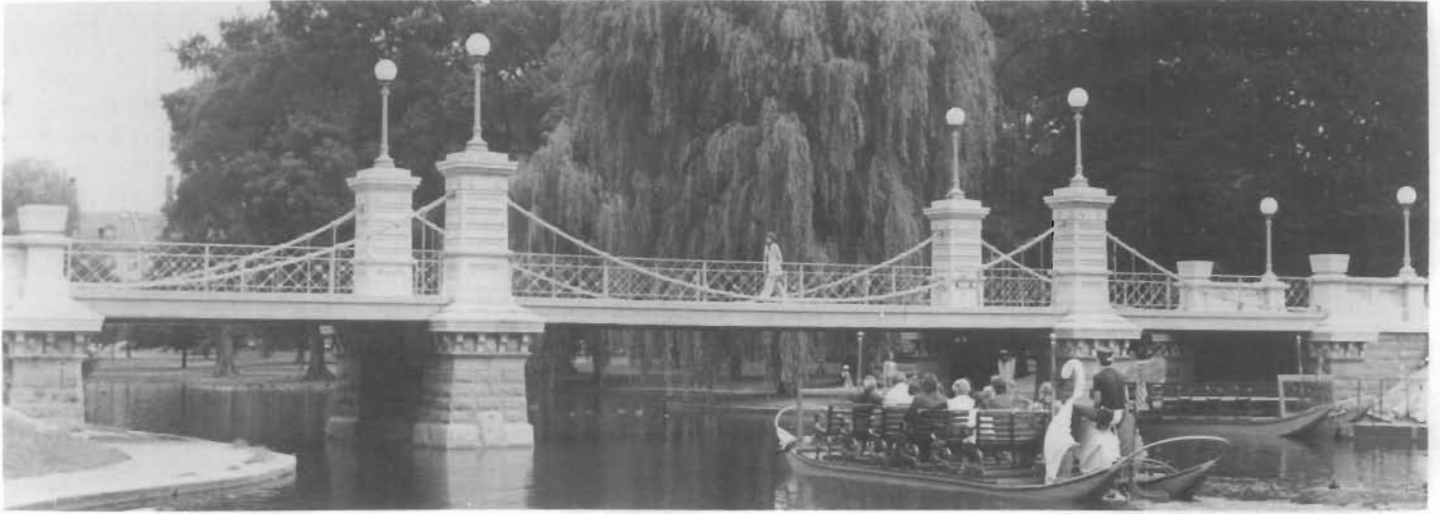
Figure 61. Suspension Bridge, Public Garden, Boston, Massachusetts, 1867; Elemens Herschel and William Preston, engineers. Popular among Bostonians, this small suspension bridge originally consisted of plank flooring hung from chains made of flat wrought-iron links. In 1921 the bridge's deteriorated wood was replaced with steel beams; the bridge was reinforced in 1975 with more steel and concrete. Although the deck has been replaced, the masonry piers and the chains hung between them are still largely original. (Carleton Knight, III)

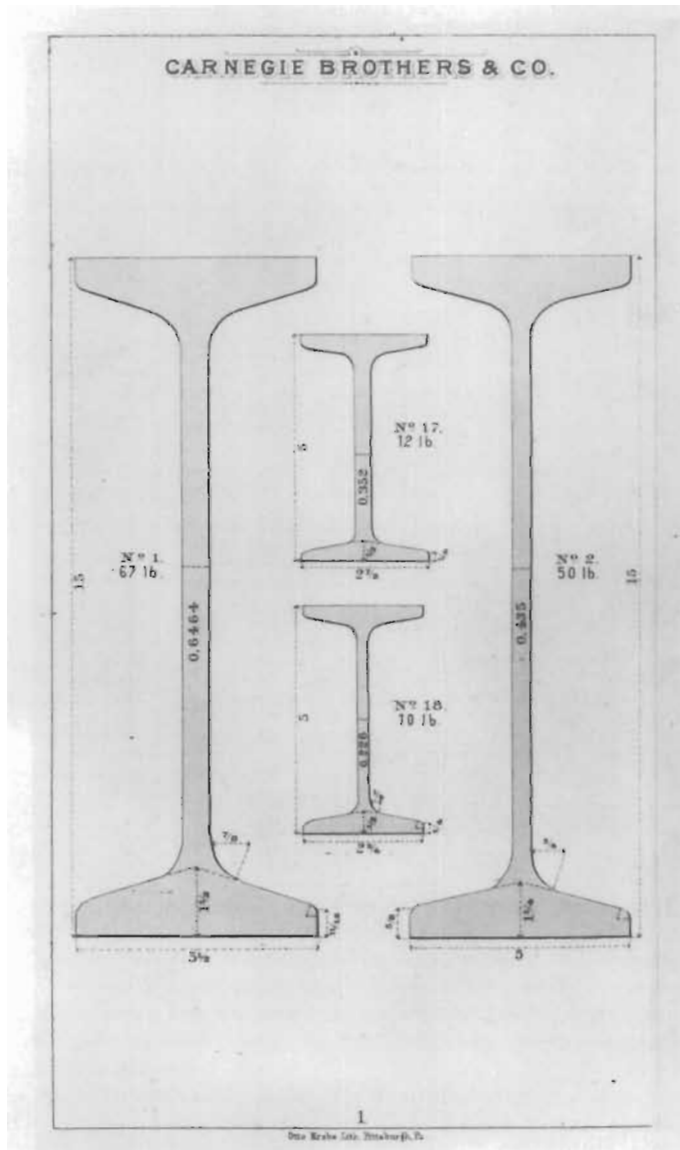
Figure 62. Wrought-iron Beams, Carnegie Brothers and Company's Pocket Companion . . . , 1876. The earliest known wrought-iron handbook of wrought iron structural shapes was published by Carnegie Kloman and Co. in 1873, some 18 years after the first wrought-iron I-beams were rolled in the United States by the Trenton Iron Works, founded by Peter Cooper. Copies of the 1873 handbook are quite rare; however, the Library of Congress has a copy of the 1876 handbook of Carnegie Brothers and Co. The Iron and Steel Beams: 1873 to 1952, published by the American Institute of Steel Construction, Inc., is a valuable resource book because it documents the handbook dates, the sizes, weights, and properties of all rolled beams during this period. The largest beam in the 1873 handbook was 15 inches deep and 67 pounds per lineal foot, the same as the beam shown in this illustration at the far left. (Library of Congress)

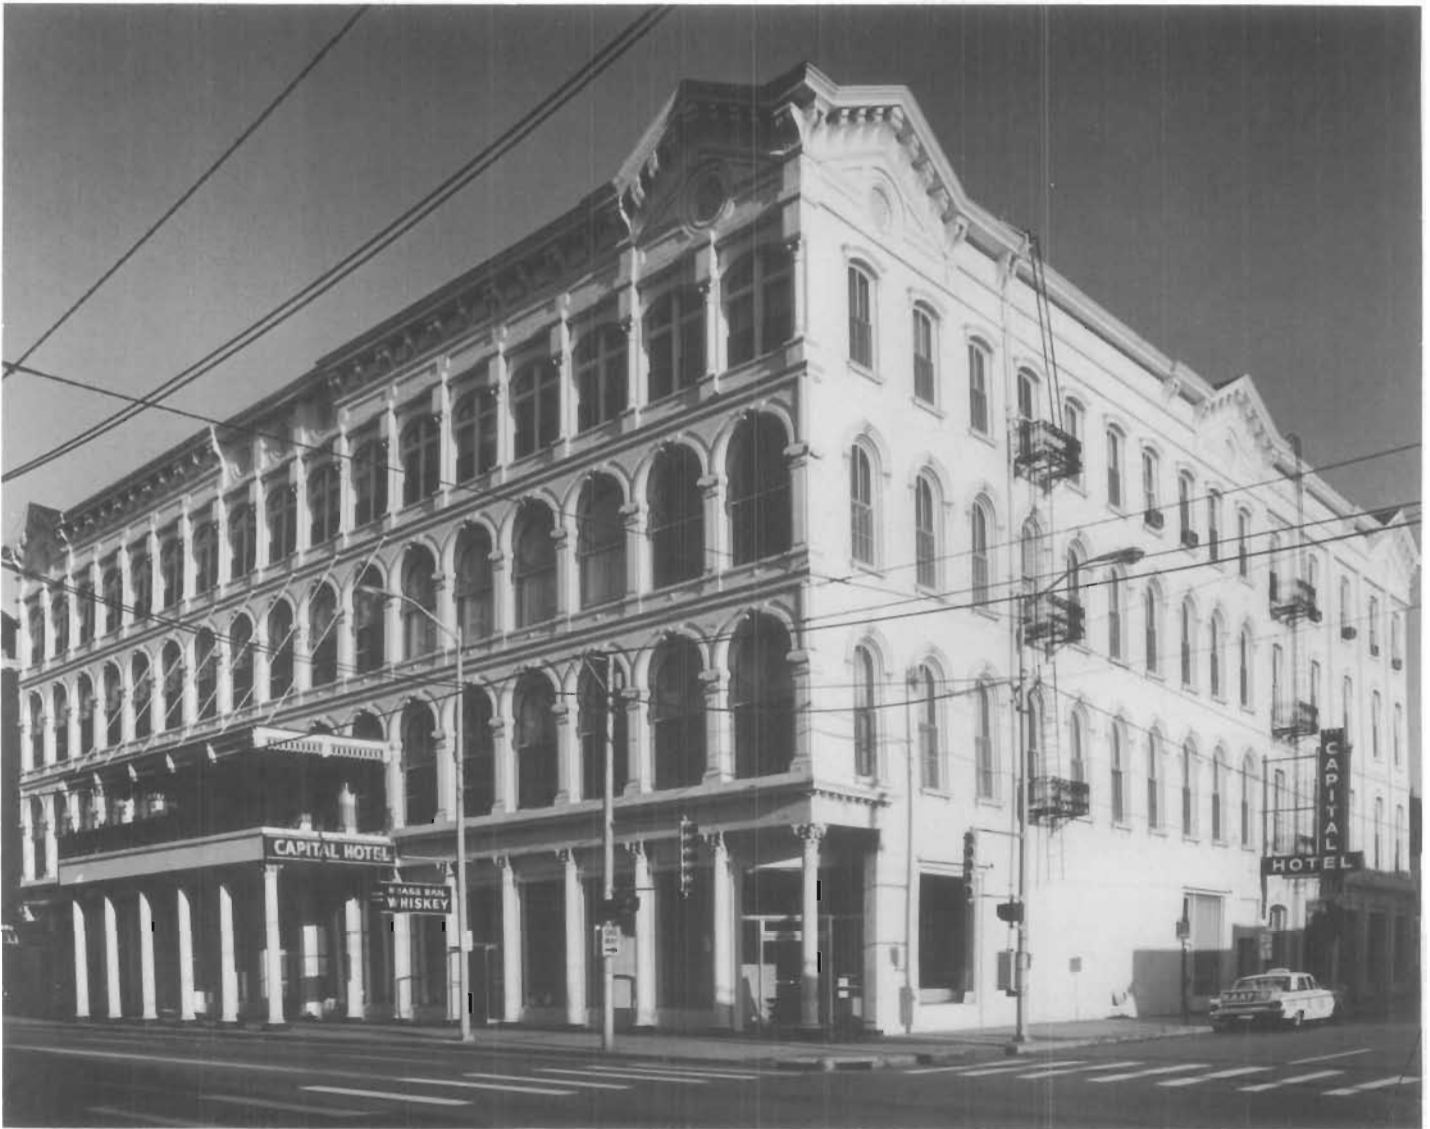
Figure 68. Cast-iron Facade, Capital Hotel (originally the Denkla Office Building), 117 West Markham Street, Little Rock, Arkansas, 1873. The Italianate office building was converted in 1877 into a hotel. Being located near the state capitol, it became popular with politicians and was often used as campaign headquarters. Note the difference in window size in the facade and the masonry sidewall. The larger windows of the cast-iron front provided a great deal of natural light, which the building's original use (offices) required. Although not apparent from a distance, the top story of the front facade and the cornice are pressed sheet metal, probably galvanized iron. (Earl Saunders)

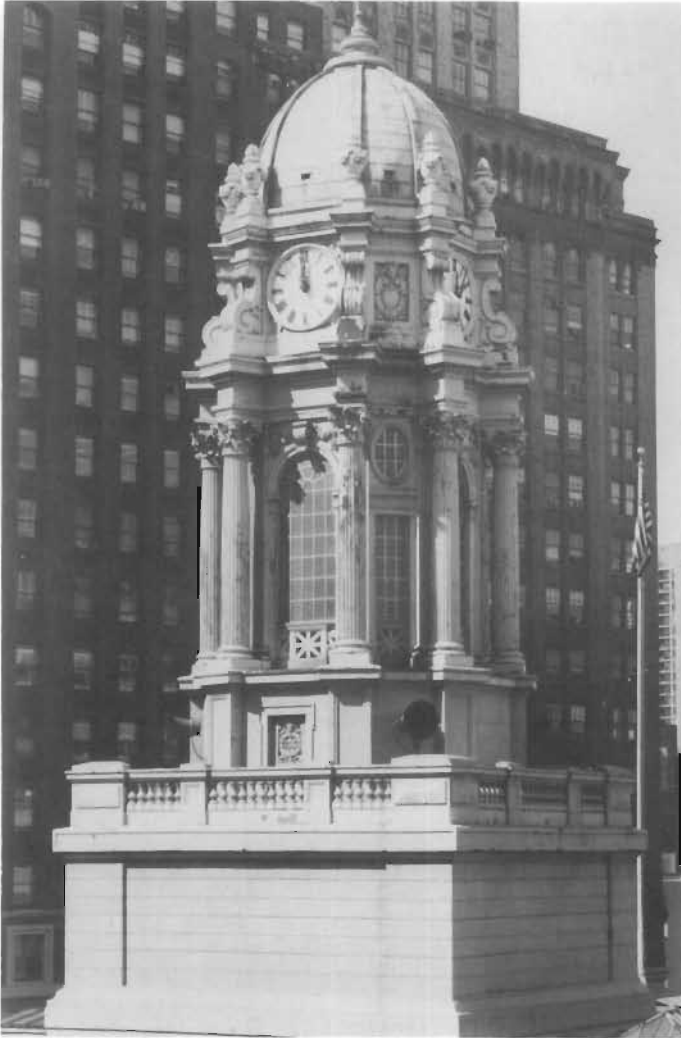
Figure 76. Cast-iron and Sheet-iron Cupola, Designed by C. W. and A. A. Houghton, architects, 1898; Hecla Ironworks; Borough Hall, 209 Joralemon Street, Brooklyn, New York, 1846–1851; Gamaliel King, architect. After the Old Brooklyn City Hall burned in 1895, it was rebuilt within the masonry shell, and a cast-iron and sheet-iron cupola replaced the wooden one that had been destroyed in the fire. It is typical of many such cupolas throughout America. (Esther Mipaas)

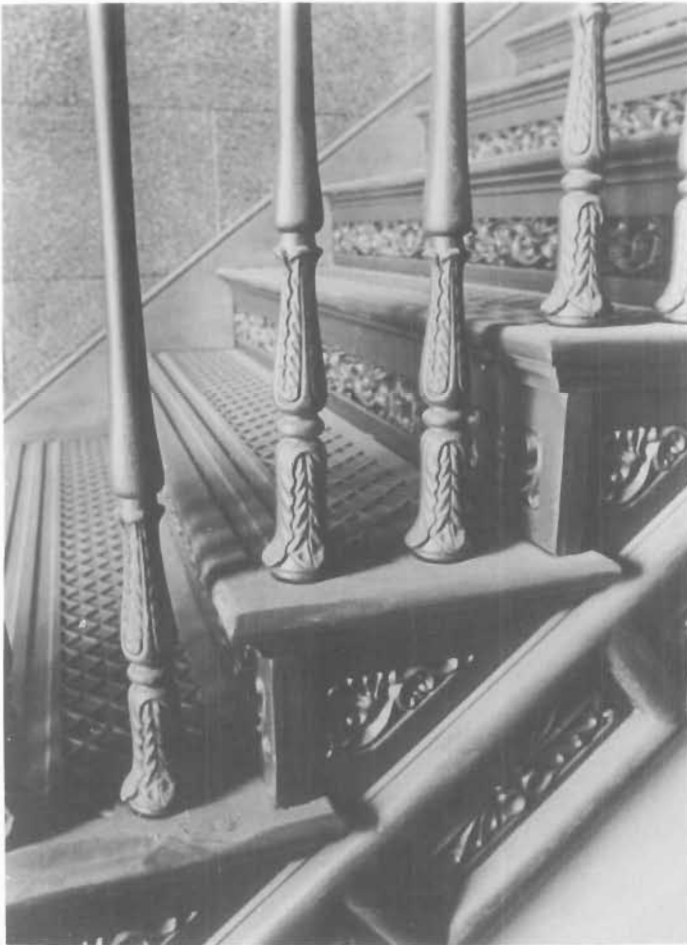
**Figure 81.** Restored Cast-iron Stairs, Old Customs House (now known as West Virginia Independence Hall), Wheeling, West Virginia, 1859; Ammi B. Young, Architect of the Treasury. In this building the people of western Virginia declared their independence during the Civil War and joined the Union. These cast-iron stairs and balusters have recently been restored with the recasting of missing or damaged pieces. Perforated stairs were originally designed to combine decorative, functional, and economical detailing; to provide elaborate but strong construction; and to reduce the weight and quantity of iron required. (West Virginia Independence Hall Foundation)

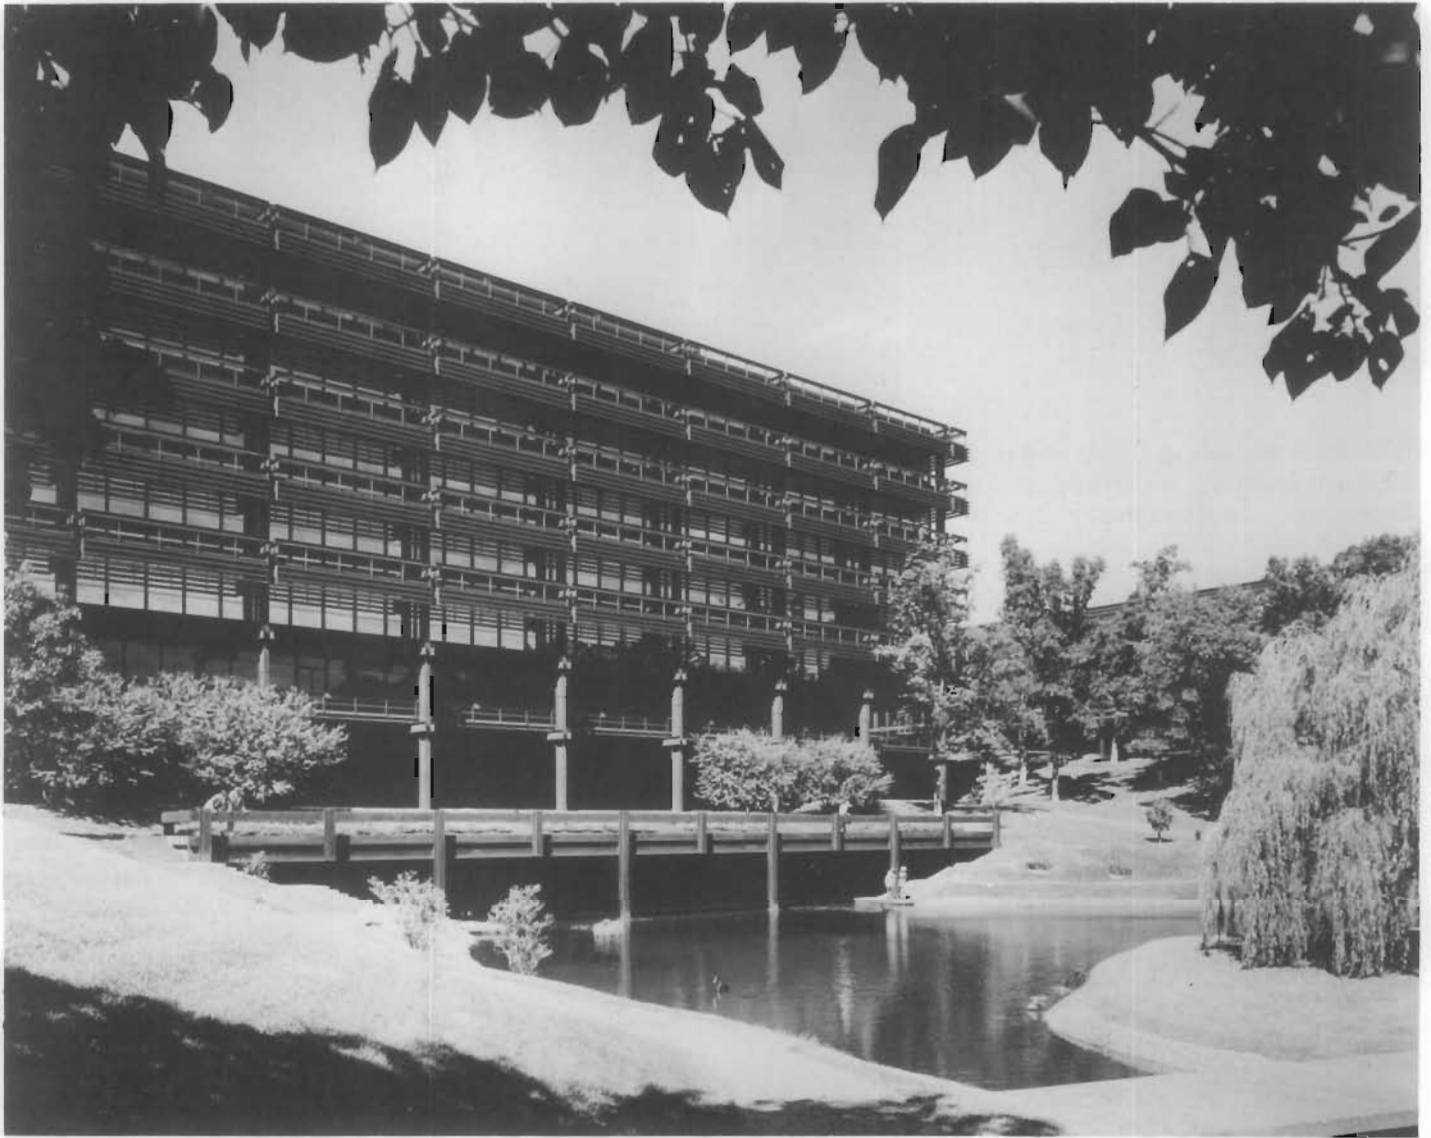
Figure 110. "Corten" Steel, Deere and Company Administrative Center, Moline, Illinois, 1964; Eero Saarinen, architect. *The Deere and Company building, which received many architectural awards, was among the first to make extensive architectural use of this unpainted, corrosion-resistant material for exterior steel members. (Deere and Company)*

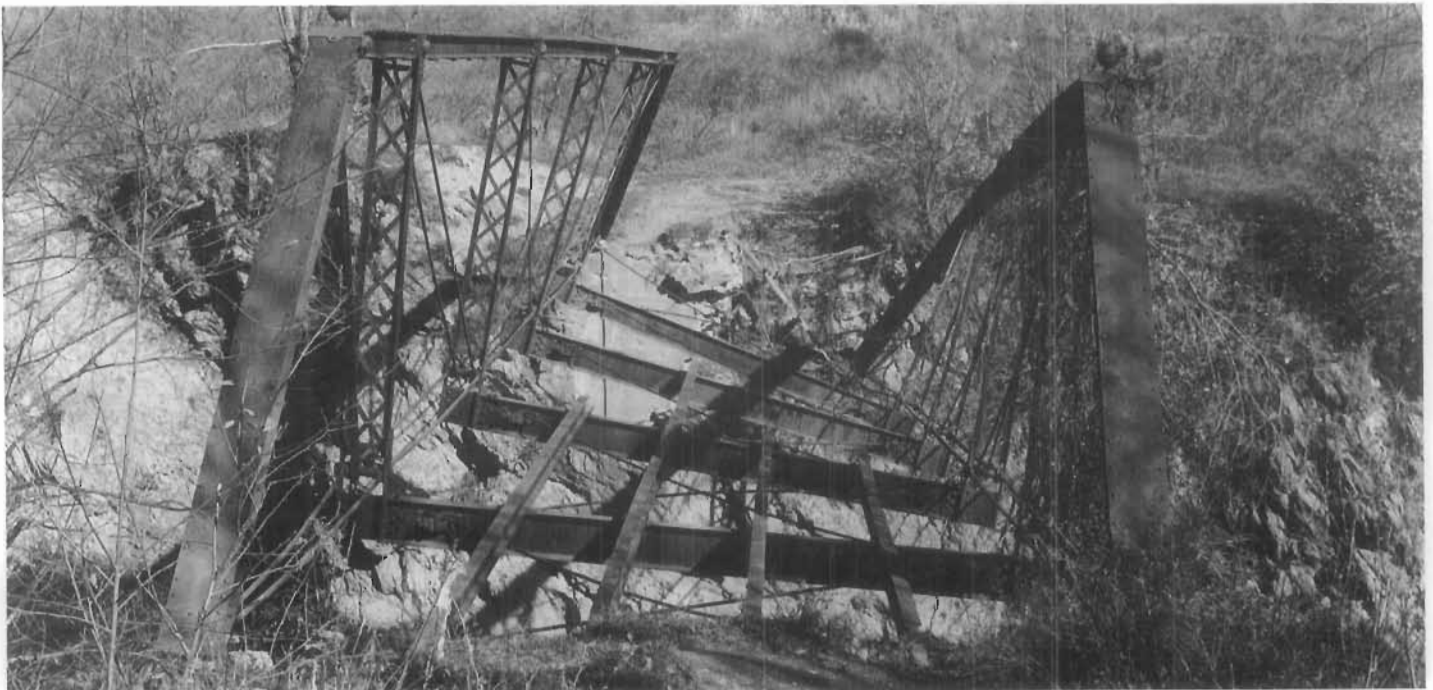
**Figure 122. Structural Failure.** This 19th-century wrought-iron truss bridge at Brunswick, New York, partially collapsed because the cut-stone abutment supporting it washed away. Once the support was removed, the bridge twisted. (John G. Waite)

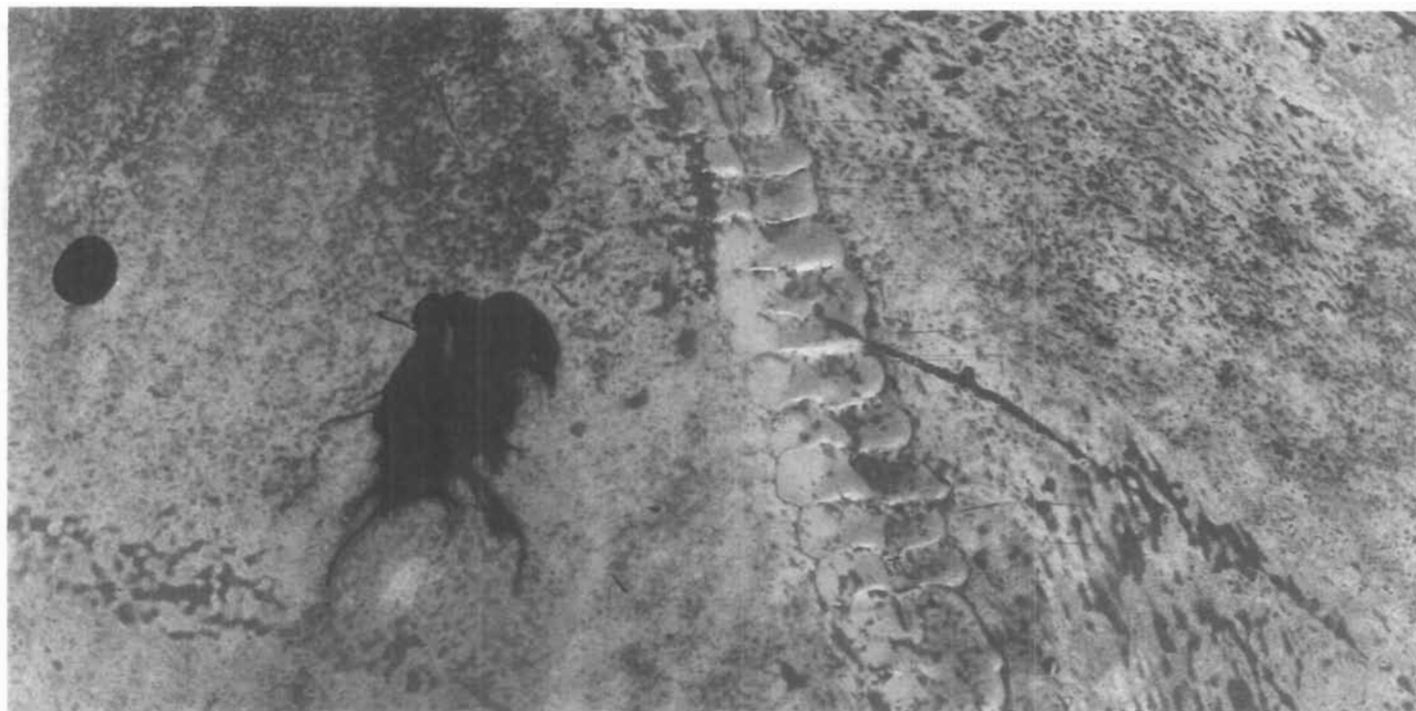
**Figure 130. Modern Solder Joint on a Terneplate Roof.** Solder was used to make watertight joints at the edges of terneplates on flat-seam roofs. Nineteenth-century soldered joints were almost invisible, that is, the solder was confined to the seam. These wide-soldered joints are on the Old Pension Building in Washington, D.C. The problems with wide-soldered joints are: (1) they facilitate galvanic corrosion because they provide a wider surface area with which the plates can react, and (2) they tend to fail because of the different coefficients of expansion and contraction of the solder and the terneplate. The black spots to the right of the solder are asphalt or a bituminous roof patching compound, which may cause deterioration of the terneplate and should be removed. (David W. Look)

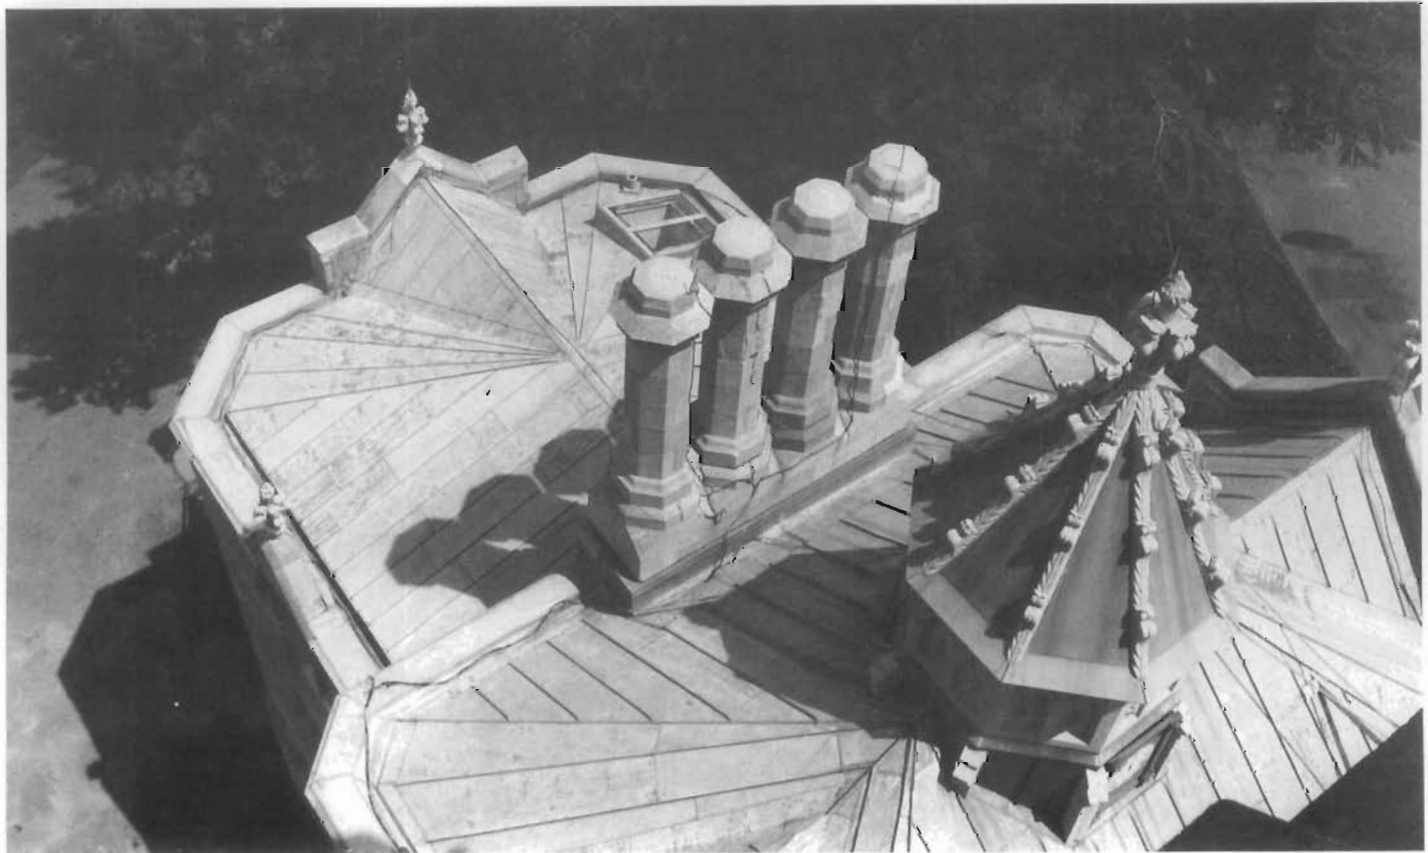
**Figure 135. Complete Substitution of Lead-Coated Copper Roofing for Terneplate Roofing.** The 1864 wing addition of Lyndhurst, Tarrytown, New York, originally had a terneplate roof. In an attempt to find a more permanent roofing material, a lead-coated copper roof was substituted for the terneplate, duplicating the pattern and sheet sizes of the original roof. In such substitutions, details may have to be redesigned because of differences in expansion and contraction rates and differences in workability of the material. The color of lead-coated copper is not the same as terneplate because terneplate roofing was never left unpainted. Therefore, lead-coated copper roofing substituted for terneplate should also be painted if it seen from normal viewing angles (usually from street level). (John G. Waite)

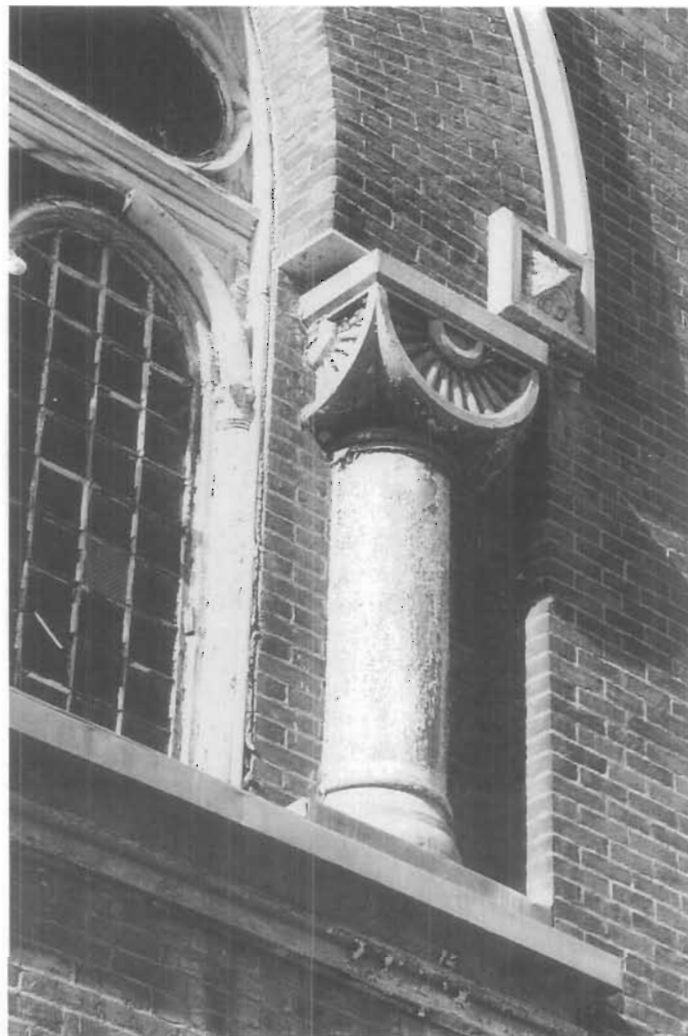
**Figure 138. Zinc Deterioration and Staining.** On the First Presbyterian Church in Alexandria, Virginia, the engaged columns, arch molding, corner blocks, and the sill molding are fabricated of cast zinc and galvanized sheet iron (the windows and frames are wood). The paint has deteriorated, leaving the surface of the metal bare in some places. The zinc or zinc coating on iron has oxidized. Notice the whitish corrosion stain on the brick from the zinc carbonate coating which continues to wash over the surface of the bare metal and then down over the bricks. The metalwork should be scraped down to remove all loose zinc carbonate. Joints should be caulked and/or resoldered, and repainted with a zinc chromate primer.  
(Baird M. Smith)

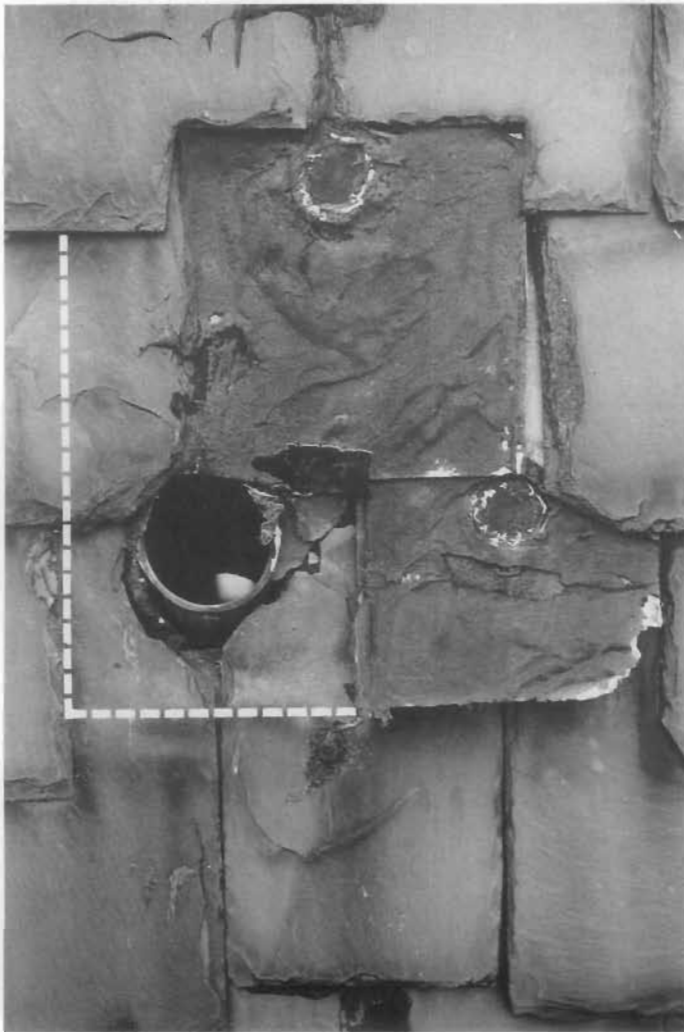
**Figure 139. Zinc Corrosion, Erosion, and Inappropriate Repairs.** In construction of the Nott Memorial at Union College in Schenectady, New York, during the 1870s, architect Edward Tuckerman Potter used “illuminators” in the ornamental slate roof. These were slate-sized zinc plates with a small colored-glass disc 1 3/4 inches in diameter inserted in the center. Barely discernible from the outside, they transformed the vaulted dome within a “heaven” of red, yellow, purple, orange, and green stars. Shown here is a cluster of three illuminators, each consisting of a zinc plate with a small colored-glass insert and the connecting tube through the metal deck and plaster to the interior. The zinc was inaccessible and not kept painted. Small fragments of slate broke off and tumbled down with gravity. The wind and rain eroded away the layer of corrosion from the zinc surface. The left plate is missing (see dotted line), showing the connecting tube. The corner of the lower right plate is missing because it became brittle and fractured off. Unfortunately, modern roofing cement applied over the zinc plates is accelerating the deterioration. (John I. Mesick, *The Nott Memorial: A Historic Structure Report Schenectady, New York: Union College, 1973. p. 65*)

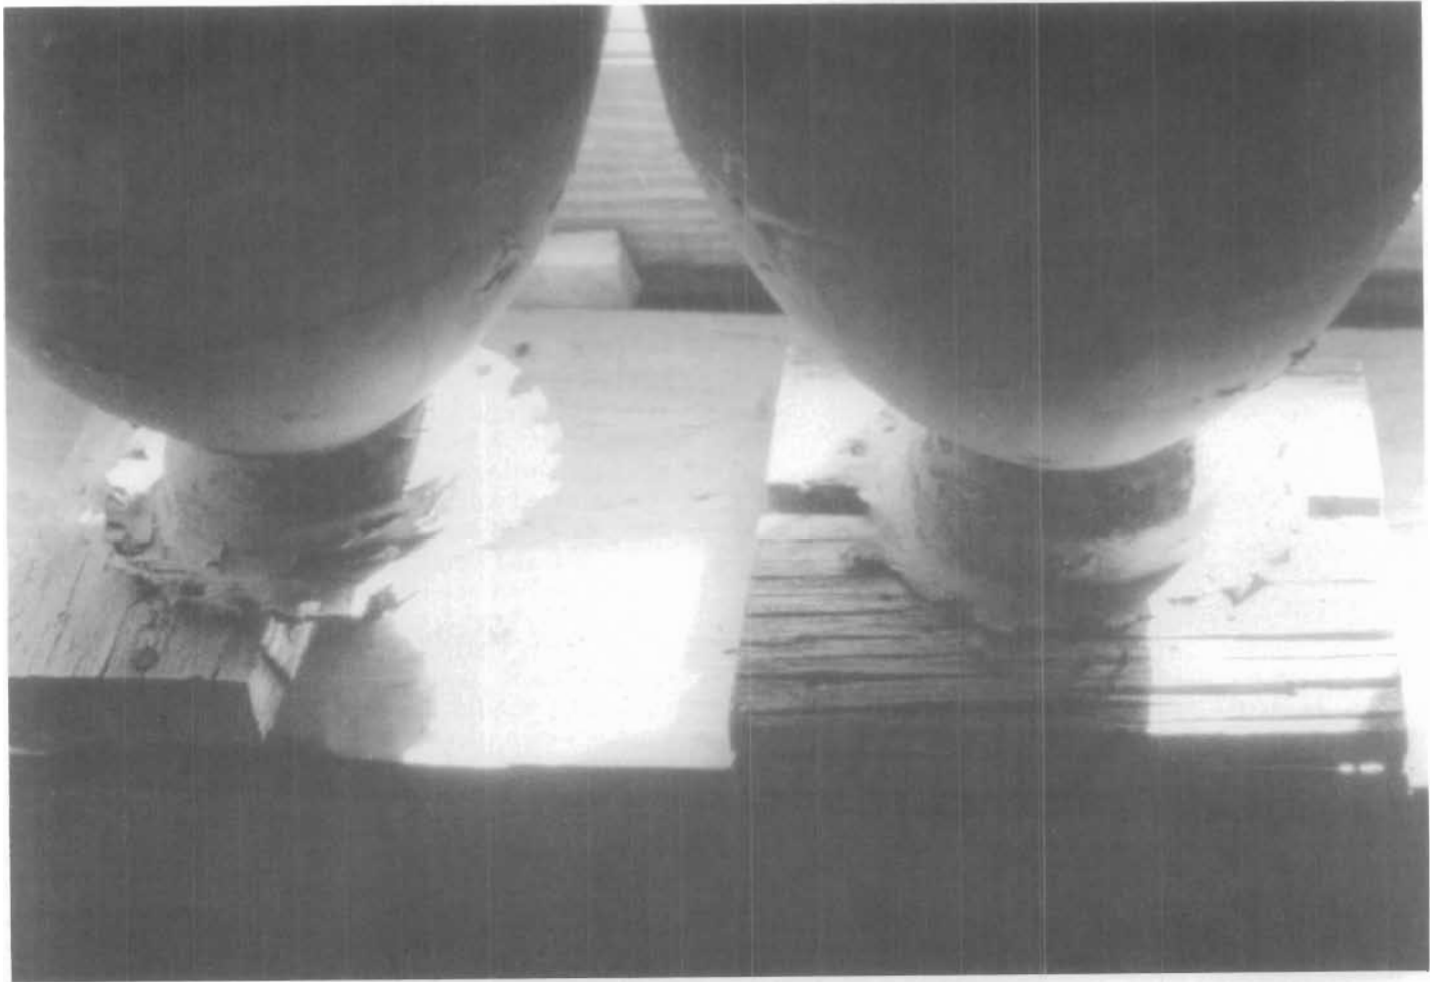
**Figure 140. Galvanic Deterioration.** Bases of zinc vases from the roof balustrade of Lorenzo, Casenovia, New York, have deteriorated because of the electrolytic action between the zinc and the machine-cut iron nails used to fasten the vases to the balustrade. The zinc was sacrificed in favor of the iron because the iron is more noble than the zinc. (Douglas Clinton)

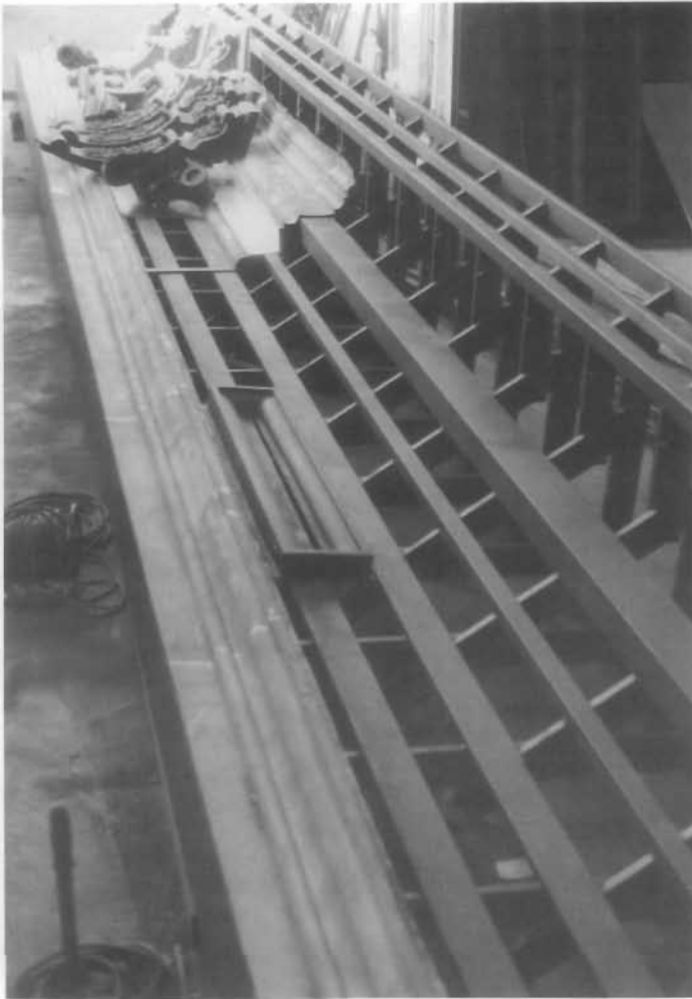
**Figure 143. Preassembling Cornice.** As illustrated in figure 142, most sheet-metal cornices were supported by wooden support members projecting out from the facade of the building either as an extension of the roof framing or as a cantilever from a parapet wall. In either case, these wooden support members are often found to be rotten and have to be replaced. For large cornices high above the street level, it may be economically unfeasible to use scaffolding for in situ repairs and reconstruction unless the scaffolding is also needed for other work. The entire galvanized sheet-iron cornice of the ZCMI Store in Salt Lake City, Utah, was pre-assembled on the ground with repaired original parts and some new pieces onto a new support system fabricated on small steel angles. Fifty-foot sections of the preassembled cornice were then hoisted to the top of the facade and bolted onto the building without the need for scaffolding. (Steven T. Baird)

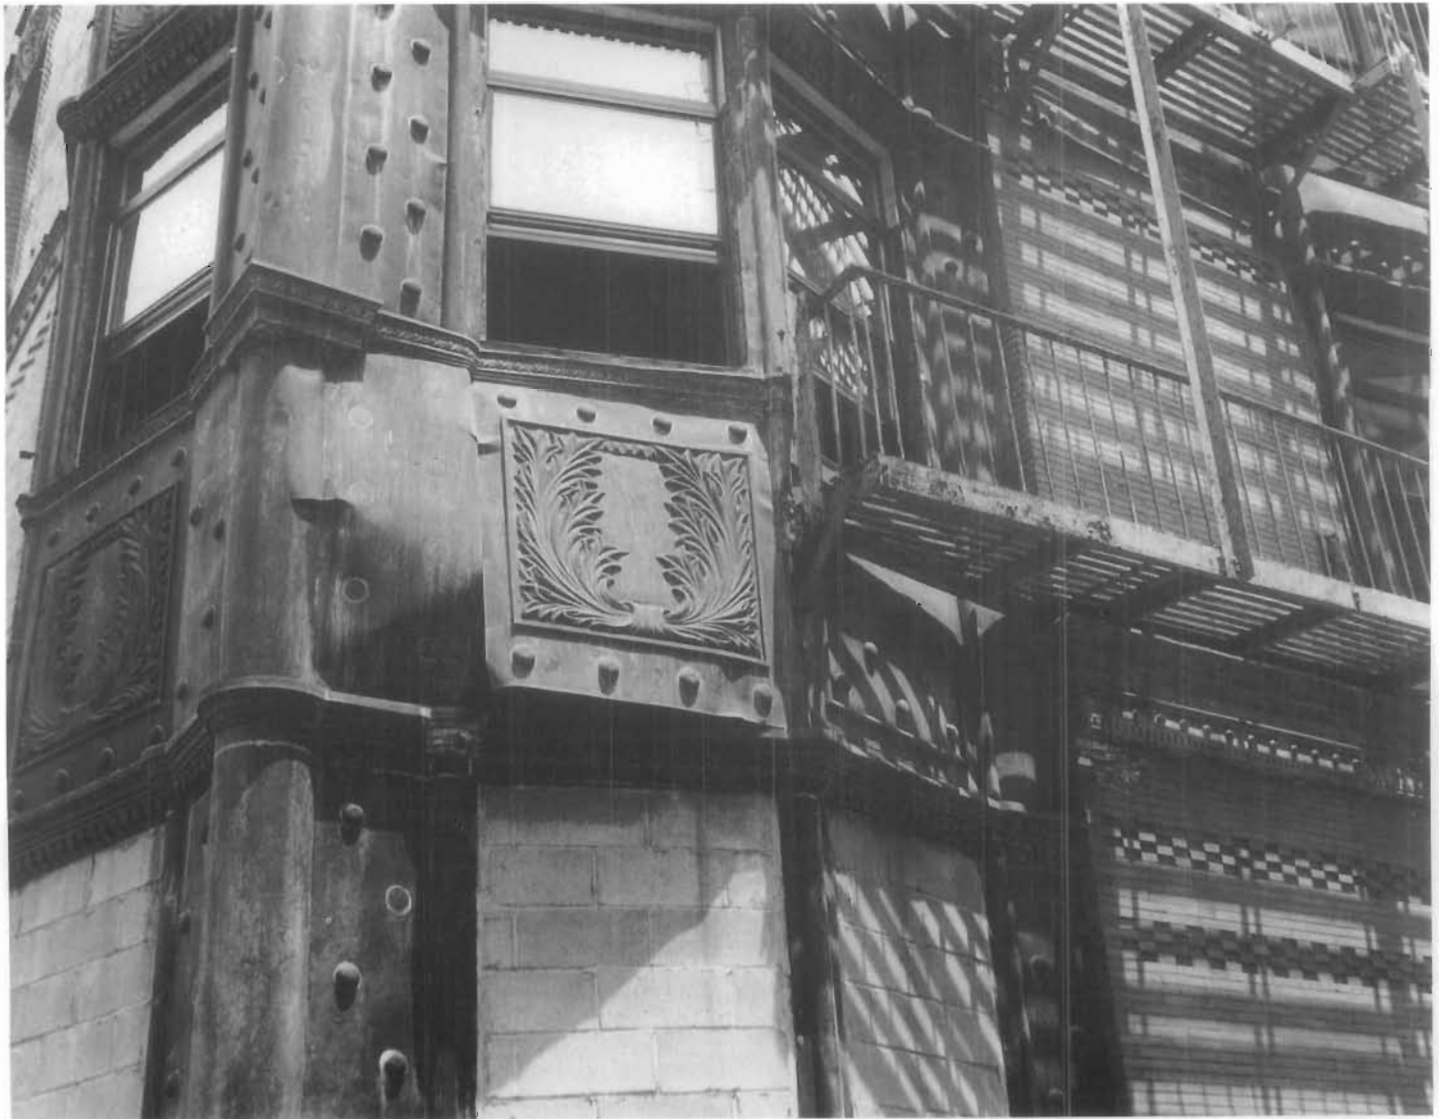
**Figure 146. Loose and Damaged Copper Cladding and Deteriorated Steel Fire Escapes.** *The corner bay of the Hotel Margueret (1889) in Brooklyn Heights, New York, was clad in ornamental panels of pressed sheet copper. Anchors have deteriorated and the wind has lifted the corners. Galvanic action between the noble copper and the baser steel (in the fire escape) has caused the steel to deteriorate.* (David W. Look)
