# **Metals in America's Historic Buildings**

Uses and Preservation Treatments

## **Part I. A Historical Survey of Metals**

## **Part II. Deterioration and Methods of Preserving Metals**

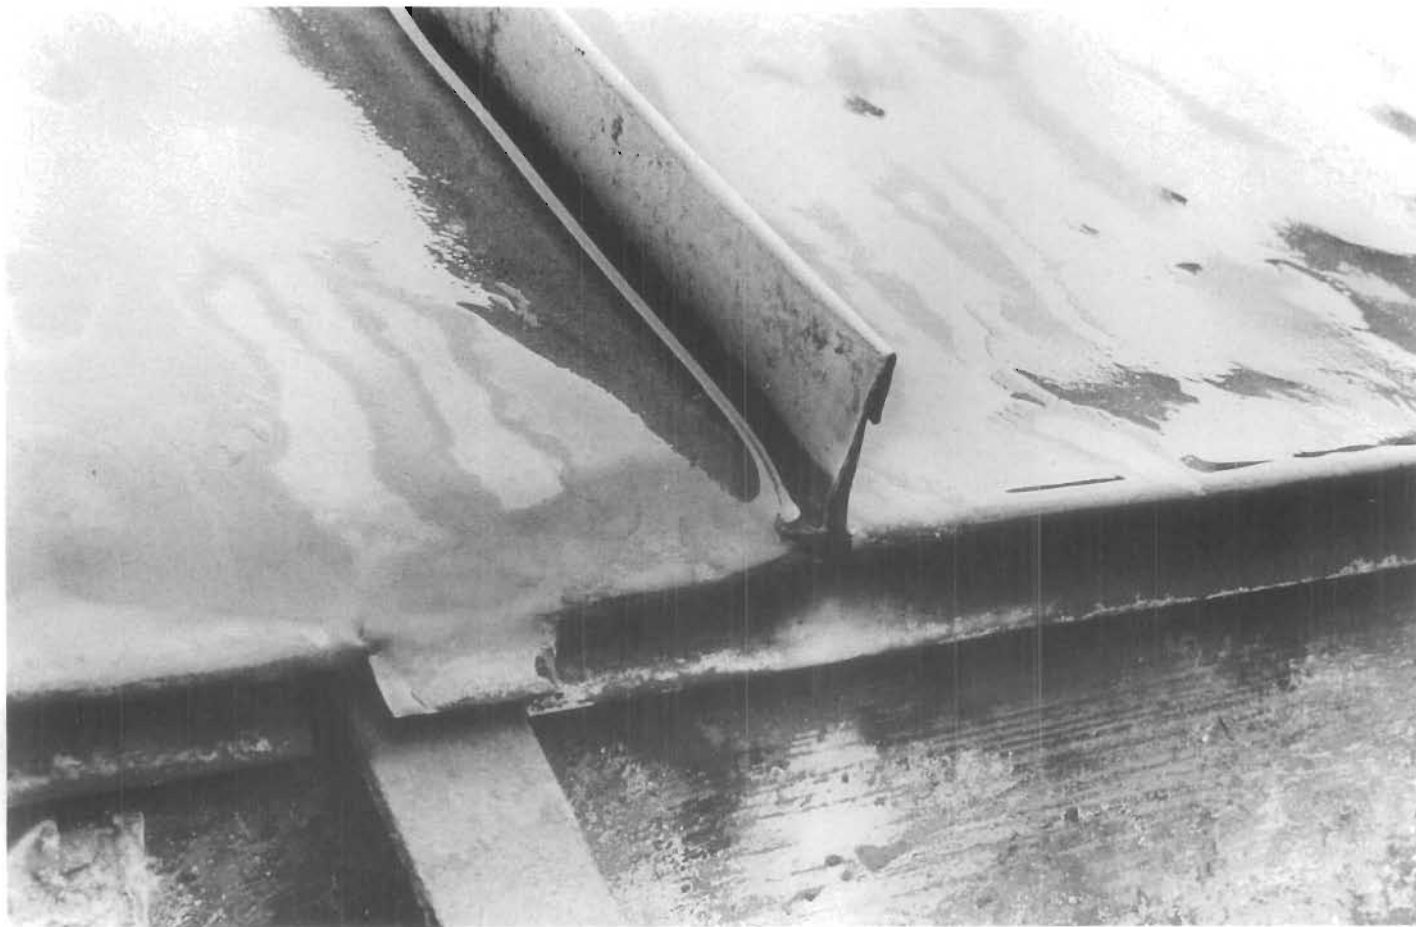
**Figure 150. Erosion of Copper.** This eaves detail of the 1920s copper roof on the Senate House State Historic Site in Kingston, New York, illustrates erosion of the copper at the edge of the roof caused by continued exposure to rain and snow, which scoured the roof as it flowed to the gutter. Fatigue failure has also occurred at the base of the standing seam, resulting in a tearing of the copper. This failure was caused by the lack of provision for expansion and contraction, as well as the use of bituminous roofing felts, which restricted the movement of the copper. (John G. Waite)

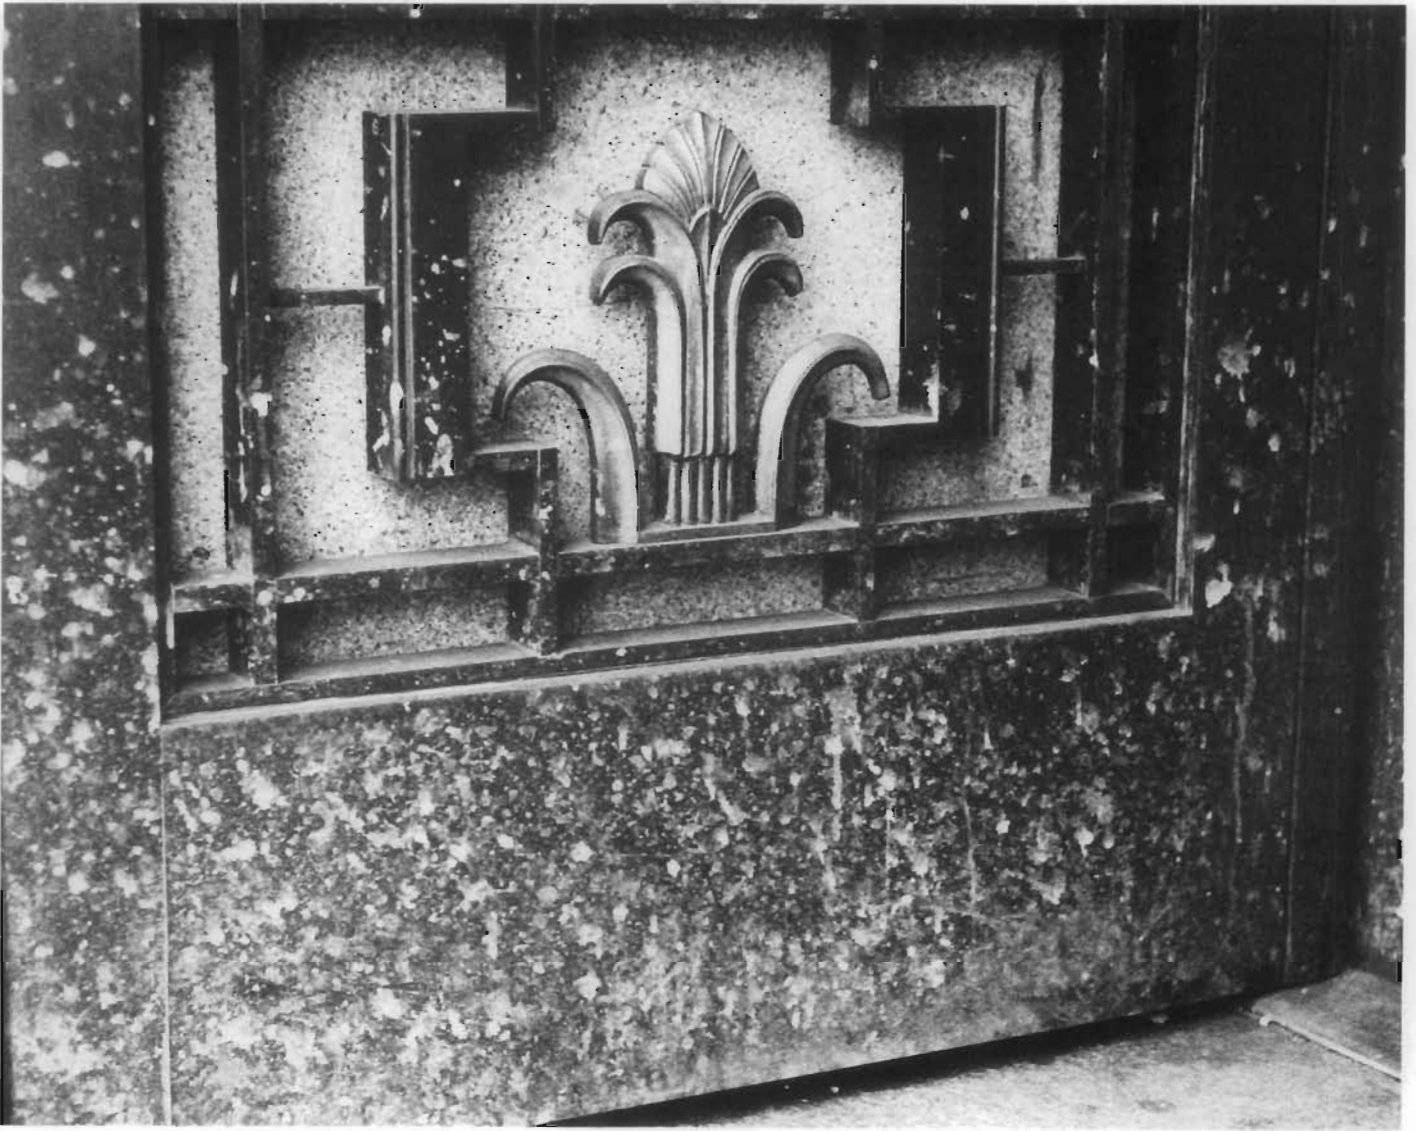
**Figure 152. Snow Salt Damage.** *On the Circuit Court of Appeals Building in Washington, D.C., the lower extremities of the exterior-bronze gates are discolored and unsightly from repeated splashing of snow-removal salt. As long as the salt remains on the gates, the bronze will continue to deteriorate and its surface may even become pitted. (David W. Look)*
