# Acid sulfate soils in subaqueous, waterlogged and drained soil environments of nine wetlands below Blanchetown (Lock 1), South Australia: properties, genesis, risks and management

R.W. Fitzpatrick, P. Shand, M. Thomas, R.H. Merry, M.D. Raven and S.L. Simpson

Report prepared for South Australian Murray-Darling Basin Natural Resources Management Board

November 2008

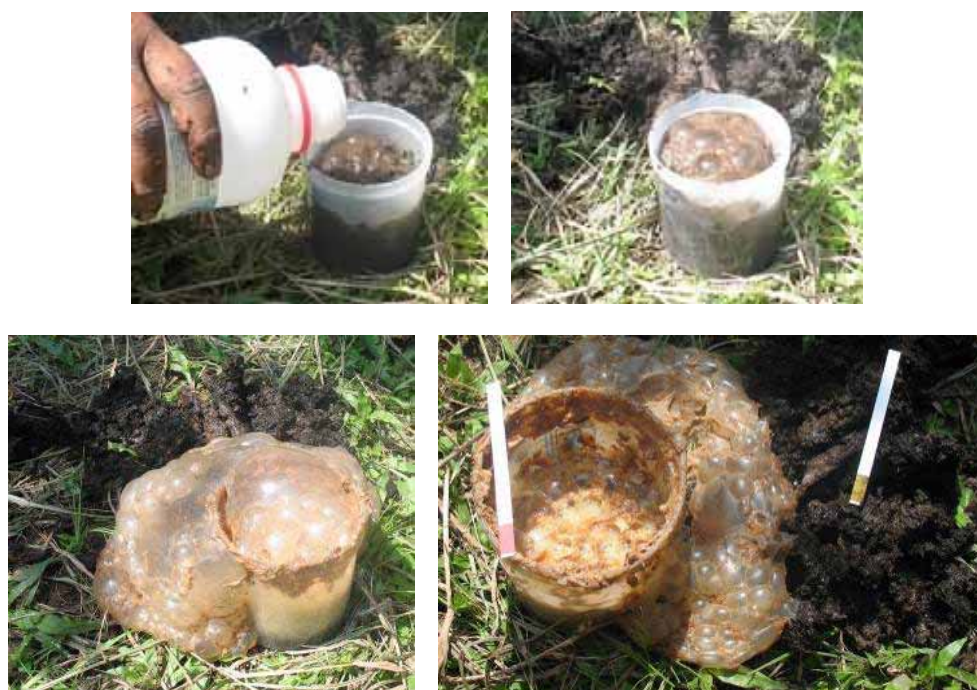
Figure 4. Photographs of the peroxide test in the field used to assess the presence of ASS (sulfidic material). Note the change in colour of the pH test strips indicating the drop in pH.

Sulfidic material + hydrogen peroxide → sulfuric acid + iron sulfate minerals + heat

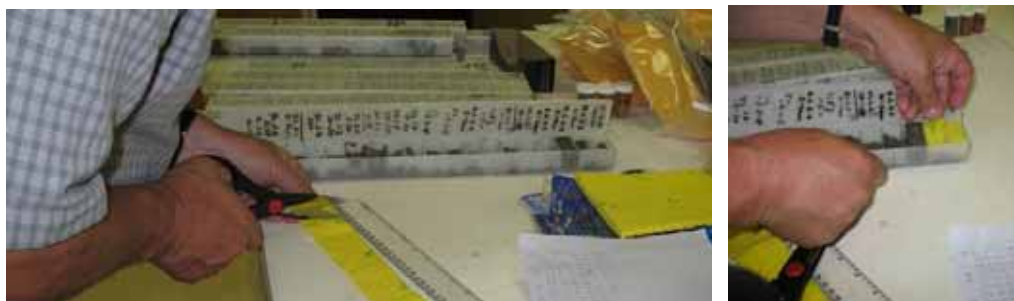
Figure 5. Field soil samples are placed in chip trays, moistened when necessary and covered with a piece of sponge. The sponge is then moistened with distilled water and the soil allowed to stand, but kept moist for eight weeks before testing with pH indicator strips.

Soil samples collected from the nine wetlands were placed in compartments of the chip tray as a 1 cm thick layer and kept moist. In the laboratory, the 1 cm thick layers of soil in each compartment were covered by a 1 mm thick piece of sponge (Figure 5), which allows slow oxygen diffusion into the moist soil sample and potential formation of sulfuric acid in the presence sulfidic materials, mimicking field conditions of drying soils. The sponge had been pre-leached with distilled water and its pH checked. The kind of sponge used did not alter the pH. In the chip tray, the sponge covering the soil sample was moistened and allowed to stand at room temperature (20 to 25 °C) for 8 weeks with occasional checking and re-moistening of the sponge with distilled water.

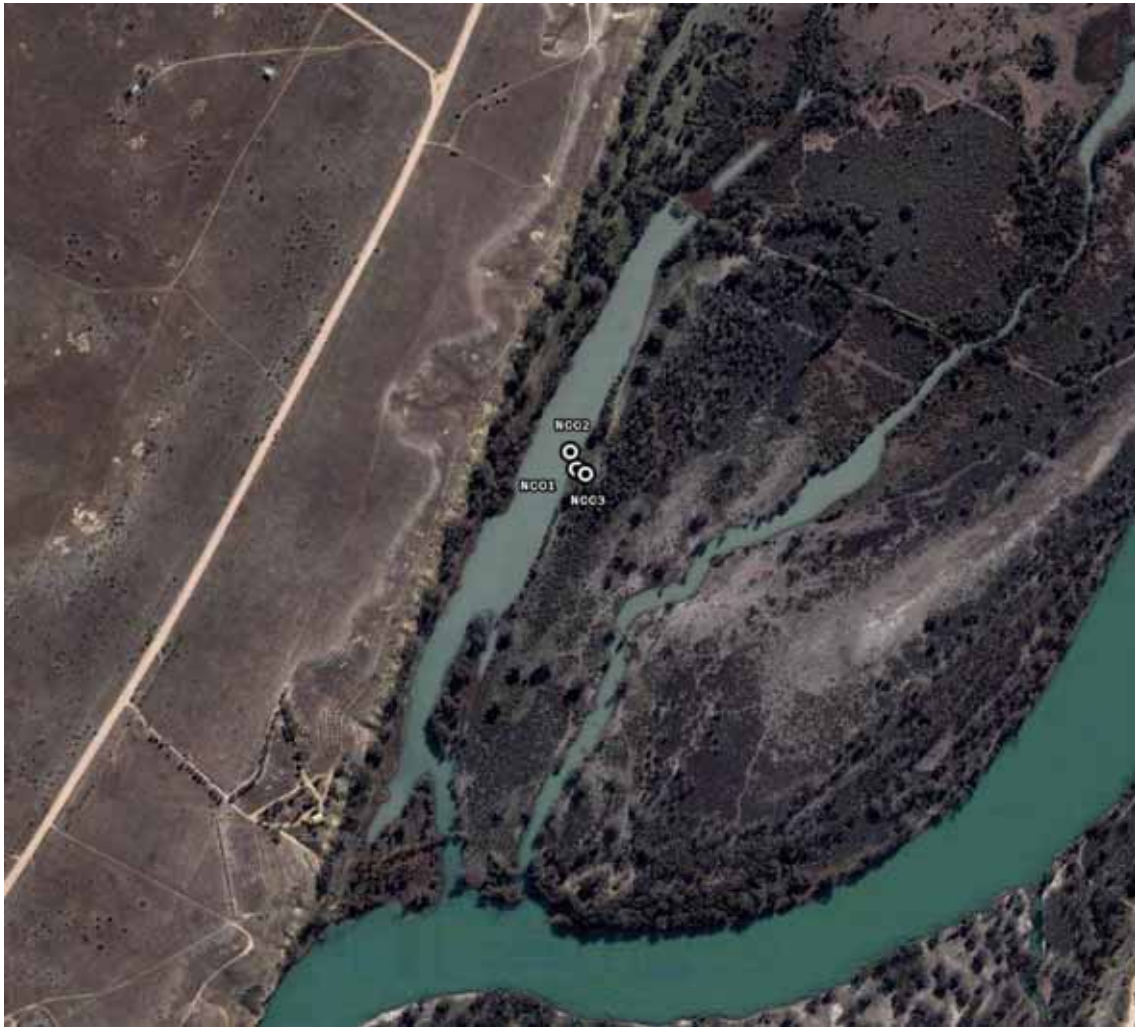
Figure 7. Noonawirra Lagoon and survey sites.

Noonawirra wetland (Figure 1), the most upstream of those surveyed, forms part of a wetland complex (Yarramundi wetland), and has been formed in a creek line (Portee Creek) (Australian Water Environments, 2008). The wetland is highly linear (approximately 1.3 km in length, and 80 m at widest). The wetland lies in a north easterly-south westerly orientation, and bound on the north-western side by a near-vertical 10 m cliff, and on the south-eastern edge by a levee bank. The outflow is at the southern end of the wetland. Sampling conducted during February 2008 was done along a 40 m tangent situated halfway along the wetland (Figure 7, Figure 8). At the time when the soil survey was conducted, the wetland was dry.

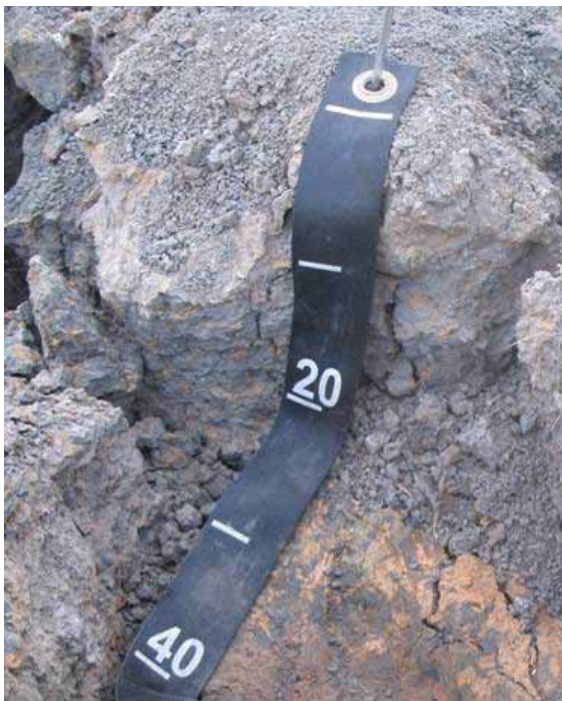
Figure 9. Photograph of profile number NOO 1 (see Table 18 and Figure 2 for location).

The profile NOO 1 (Figure 9) was sampled in a zone of sparse herbage approximately 7 m from the bank of the wetland. This site was characterised by peds with a self-mulching clay surface that were separated by wide ( $> 2$  cm) cracks. The profile NOO 2 (Figure 11) was taken in the middle of the wetland, and featured a loose, crumbly surface of self-mulching clay in an area of abundant carp bones, indicating this to be a locally low point in the wetland and a last refuge for carp as water level receded. The profile NOO 3 (Figure 13) was taken between the shoreline and NOO 1, and featured a surface of similar appearance to NOO 1, although with a greater density of herbage present.

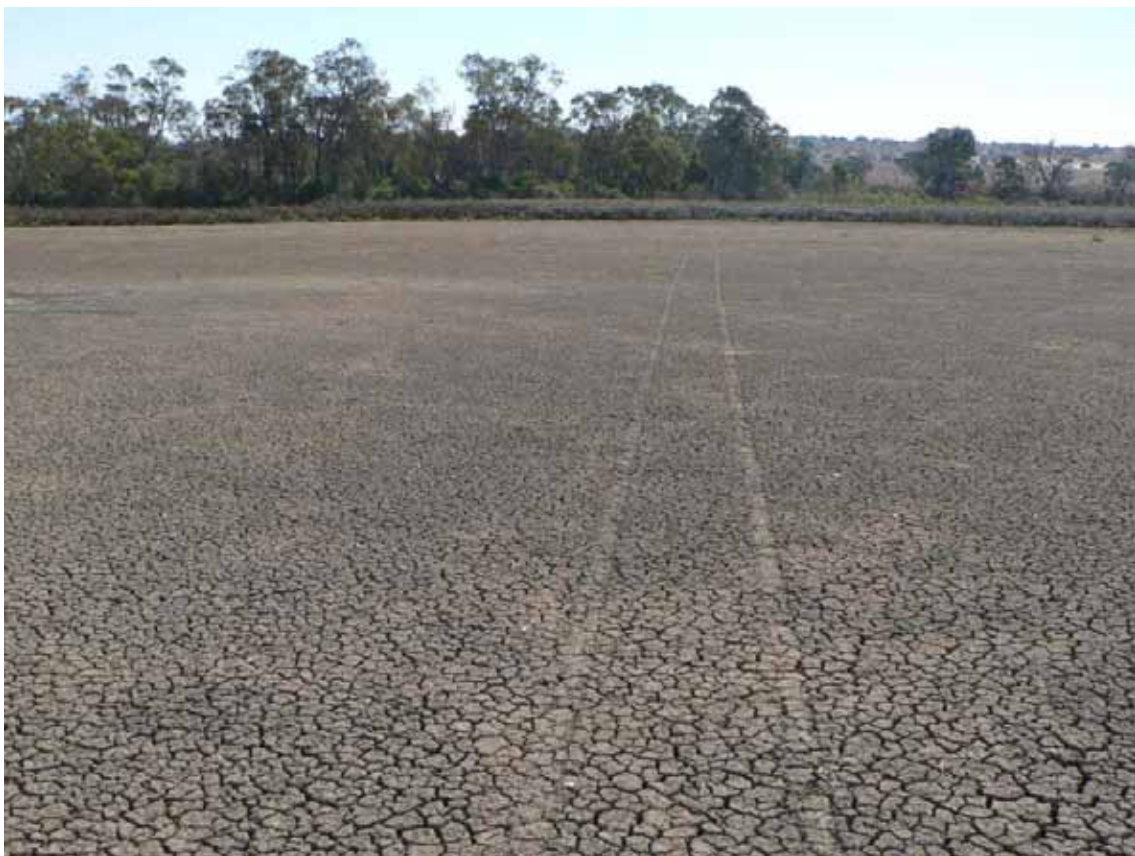
Figure 19. Landscape context of Devon Downs North wetland, taken from near the southern end, and viewed westwards (see Figure 2)

Devon Downs North (Figure 1) is a large, linear wetland that is approximately 6.5 km long, and approximately 800 m at the widest (southern end). The wetland is fringed on the river side (east) by a flood levee, and on the landward side (west), by steep gradient cliffs and low gradient footslopes and toeslopes, much of which are under agriculture. During the time of the visit (April 2008), Devon Downs North was completely dry (Figure 19), with much of the wetland surface comprising cracked clays in the south, and an almost continuous cover of *Phragmites australis* in the northern end. At the northern end of the wetland are a series of channels (now dry), and much of this area has clear evidence of salinity. Australian Water Environments (2008) present a full account of the botanic and habitat status of the wetland.

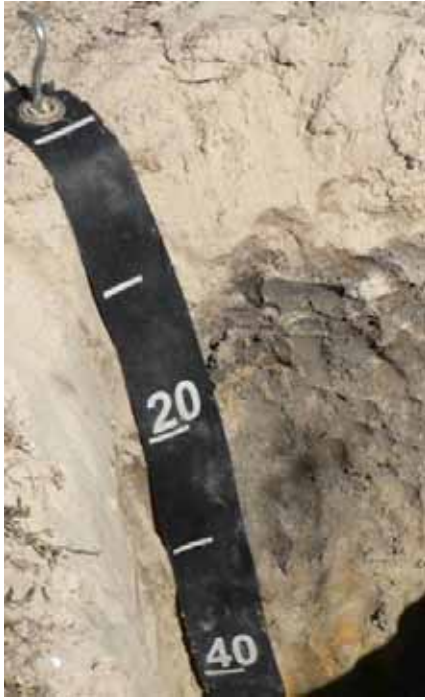
Figure 21. Photograph of profile number DD 1 (see Table 18 and Figure 2 for location).

The profiles DD 1 and DD 2 (Figure 20) were taken from the southern zone of the wetland from each end of a 150 m transect. DD 1 (Figure 21) was taken from a sandy beach on the fringe of a wooded promontory, and DD 2 (Figure 23) was taken adjacent to this, towards the middle of the lagoon.

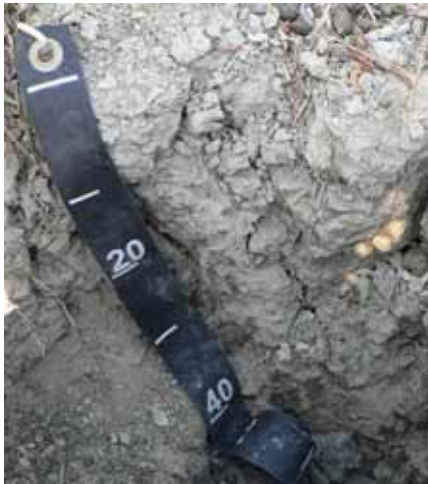
Figure 25. Photograph of profile number DD3 (see Table 18 and Figure 2 for location).

The DD 3 (Figure 25) and DD4 profiles were taken from the northern end of the wetland at each end of a 50 m transect. DD 3 was taken from towards the centre of the wetland from a dry clay zone. DD 4 (Figure 27) was taken on the wetland side of a shore-fringing zone of *Phragmites australis*, which formed a continuous barrier to the shore approximately 7 m deep.

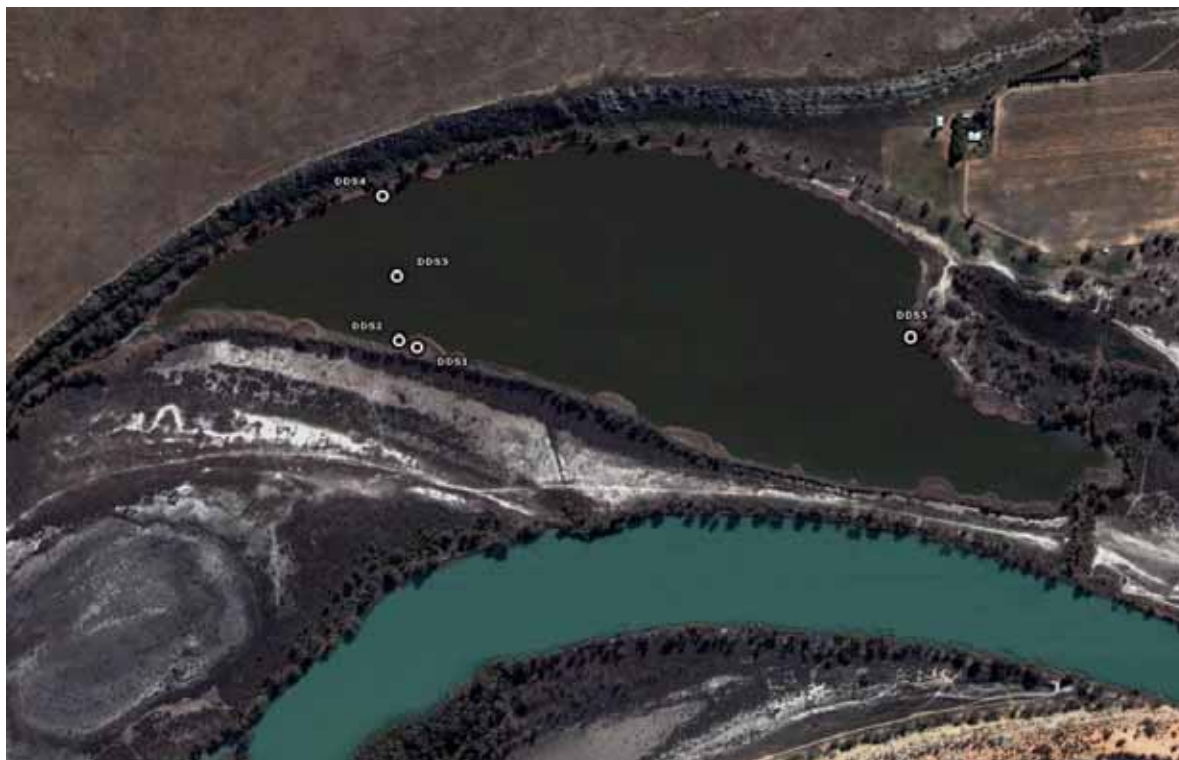
Figure 29. Devon Downs South with survey sites.

Devon Downs South (Figure 1) is approximately 1.6 km at longest, and 450 m at widest. To the south, the wetland is bound by a river levee (Figure 29). The north western side of the northern edge features a steep cliff (approximately 10 m) with narrow colluvial toeslope (10 m), while the north-eastern side of the northern edge is defined by a low gradient slope that is under farm management. Australian Water Environments (2008) present a full account of the botanic and habitat status of the wetland. At the time when the soil survey was conducted, the wetland was dry (Figure 30).

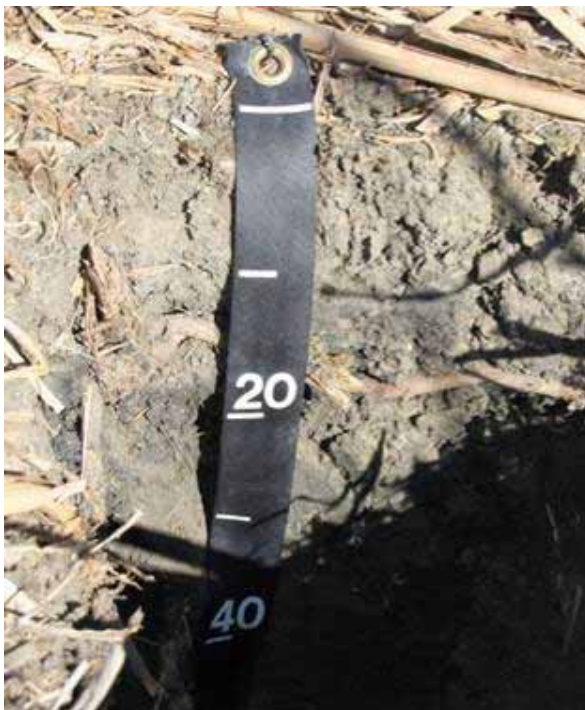
Figure 31. Photograph of profile number DDS 1 (see Table 18 and Figure 2 for location).

The sampling was based on a 260 m transect situated in the western end of the wetland, oriented south to north. The profile DDS 1 (Figure 31) was situated in a *Typha* stand on a small promontory on the southern bank of the wetland. DDS 2 (Figure 33) was taken outside the *Typha* stand, approximately the same distance for the shore. DDS 3 (Figure 35) was taken from the equidistant from both shorelines along the transect. DDS 4 (Figure 37) was taken from the shore on the northern end of the transect. Sampling locations were dominated by a steep cliff (approximately 15 m), with a narrow band of colluviated slope, with the shoreline at its base. DDS 5 (Figure 39) was taken from the eastern shore in a sandy area, which featured a cover of salt efflorescences. The sandy texture, landscape position and surface efflorescences indicated the area to be a saline discharge zone.

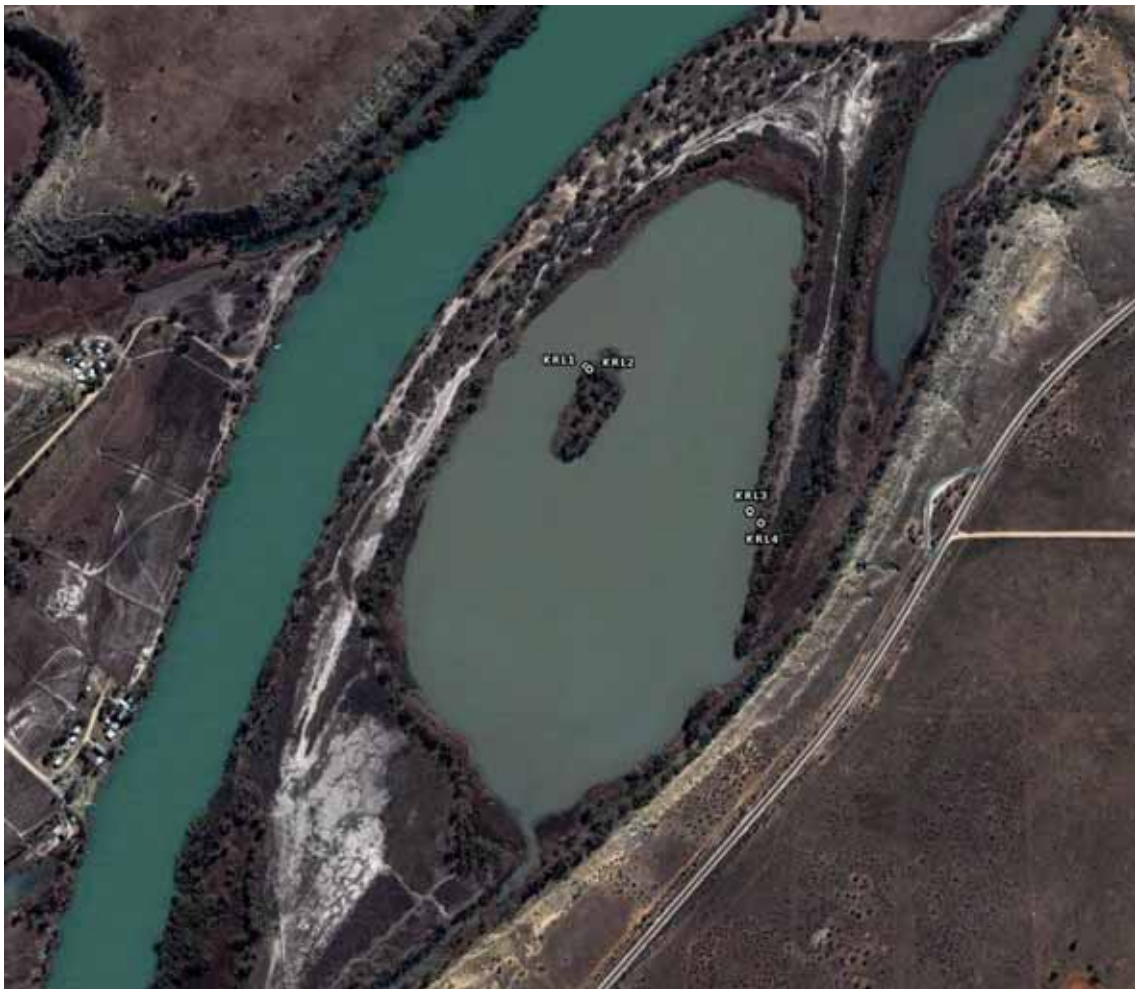
Figure 41. Kroehns Landing and survey sites.

Kroehns Landing wetland (Figure 1) is approximately 1.1 km at longest and 600 m at widest (Figure 41). The wetland is located on the eastern bank of the river, and is separated by a levee bank. Much of the eastern shore of the wetland is dominated by a steep cliff (approximately 15 m). A small island (< 1 ha) is located towards the western shore. The wetland is fed by a northern channel and drained by a southern channel. At time of sampling the wetland was dry (Figure 42). A full account of the habitat quality is presented in Australian Water Environments (2008).

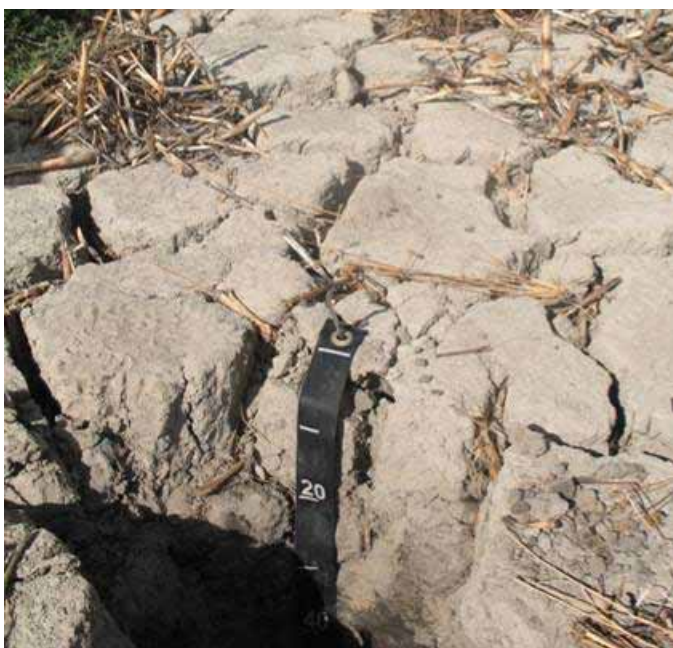
Figure 43. Photograph of profile number KRL 1 (see Table 18 and Figure 2 for location).

Soil sampling was conducted close to the island, with the first site (KRL 1, Figure 43) near to the shore of the island. KRL 2 (Figure 45) was taken 10 m away, almost on the shore of the island in a stand of *Phragmites*. KRL 3 (Figure 47) was taken on the eastern bank of the wetland, close to the base of the cliff, which dominates. KRL 4 (Figure 49) was taken 30 m away, in the edge of a stand of *Phragmites*.

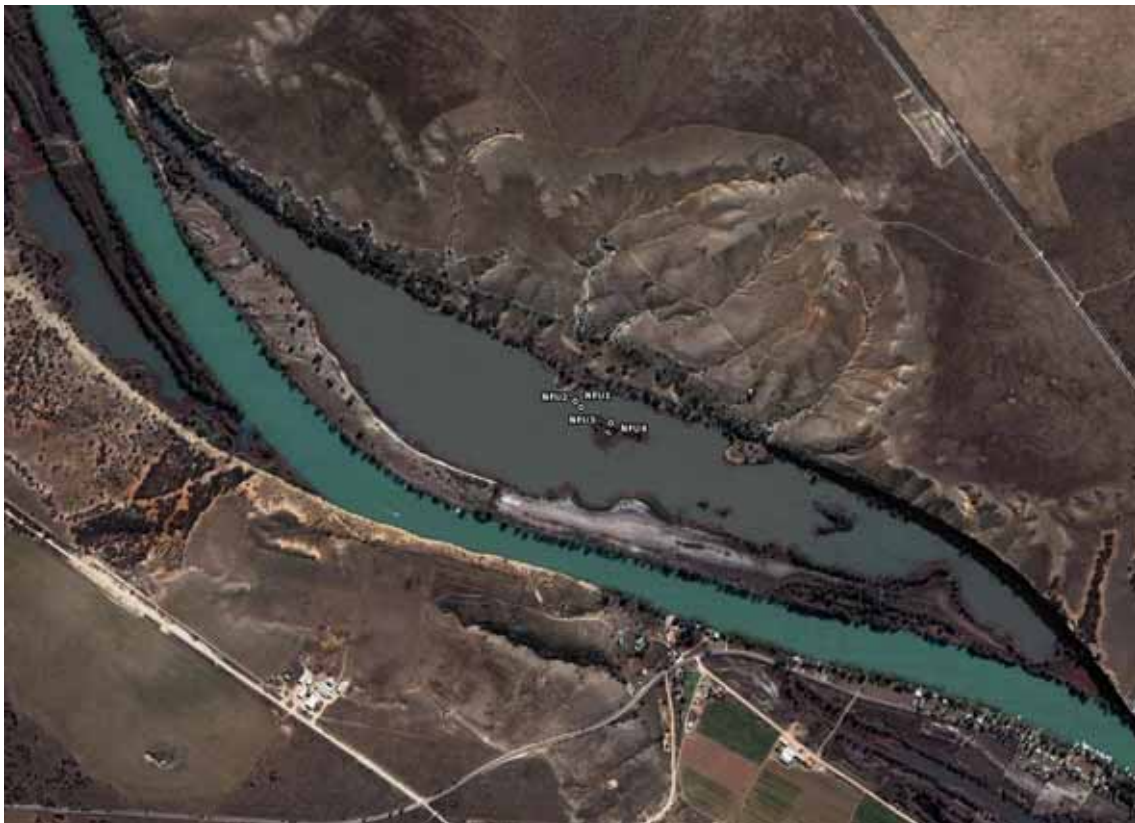
Figure 51. North Purnong wetland and survey sites.

North Purnong (Figure 1) is a linear wetland on the north bank of the river. The wetland is highly linear, with a length of approximately 3.5 km, and a maximum width of 450 m (Figure 51). The wetland is separated from the river by a levee bank, and contained to the north by an eroded cliff in places, and others, a steep cliff face. The cliff is approximately 20 m. The wetland contains four islands. An account of the habitat quality is presented in Australian Water Environments (2008). At the time of sampling the wetland was dry (Figure 52), and we were advised by the landholder that the drying completed during January 2008.

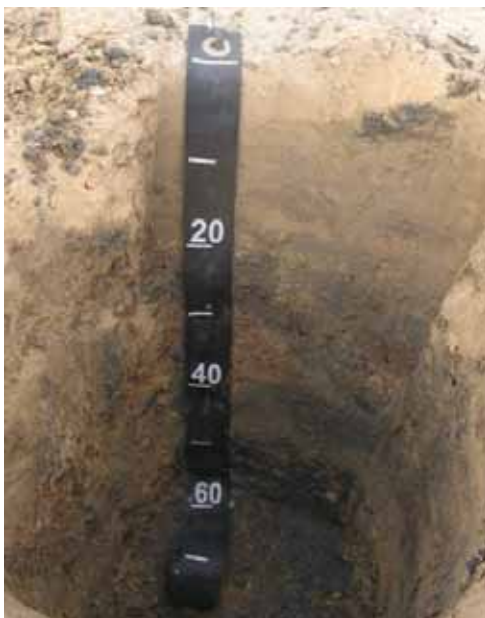
Figure 53. Photograph of profile number NPU 2 (see Table 18 and Figure 2 for location).

Of the soil profiles described, sampling was conducted on a transect from the north bank to the largest island 120 m away, on an east-southeast bearing. NPU 2 (Figure 53) was sampled near to the north shore in a sandy area. NPU 3 (Figure 55) was sampled approximately half way between the north shore and the island, in a locally low lying area – by evidence of the many carp skeletons present. NPU 4 (Figure 57) was taken from the island amongst a stand of *Typha*.

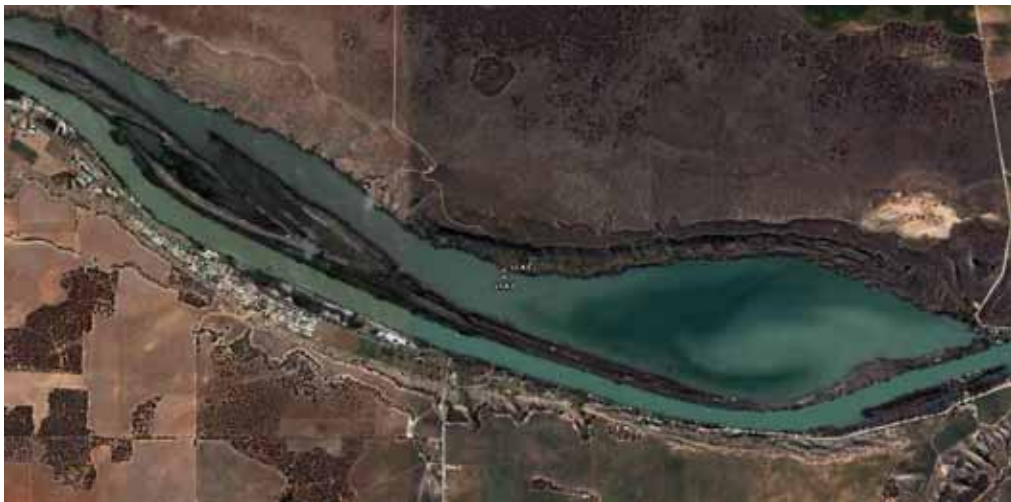
Figure 59. Lake Carlet and survey sites.

Lake Carlet (Figure 1) is a large wetland on the north bank of the river. It is approximately 7.5 km long, and 1 km at widest (Figure 59). The wetland is separated from the river by a levee bank, while the north bank of the wetland is formed steep and eroded cliffs (approximately 25 m). Australian Water Environments (2008) present a full account of the habitat quality. At time of soil survey, the wetland was still flooded (Figure 60).

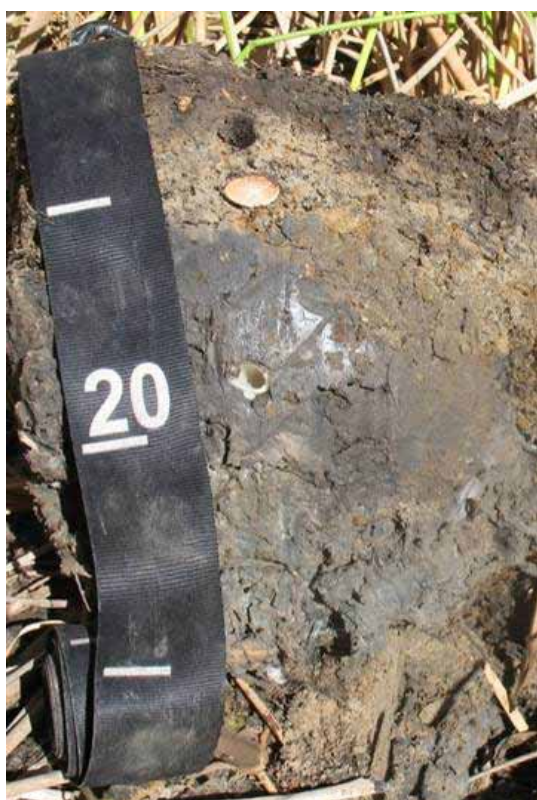
Figure 61. Photograph of profile LCA 1 (see Table 18 and Figure 2 for location).

Soil sampling was conducted on a transect emanating from the shore of the north bank at the base of the eroded cliff, to 45 m beyond the shore. LCA 1 (Figure 61) was collected from inside a stand of *Phragmites* above the shoreline, whereas LCA 2 (Figure 63) was taken 10 m away on the shore. LCA 3 (Figure 65) was a subaqueous sample taken from a subaqueous ASS tangential from the previous samples.

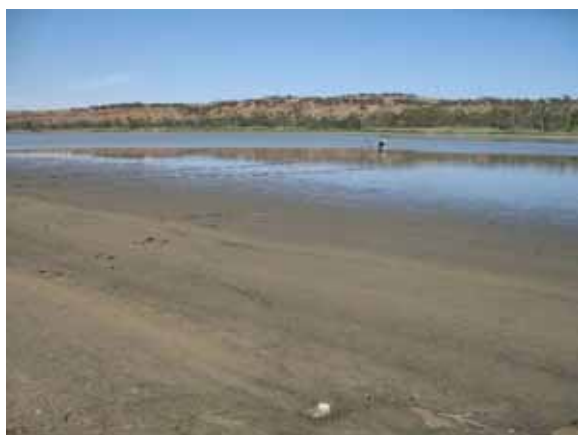
Figure 65. Photograph of person standing at the site in the lake where profile LCA 3 (see Table 18 and Figure 2 for location) was taken.

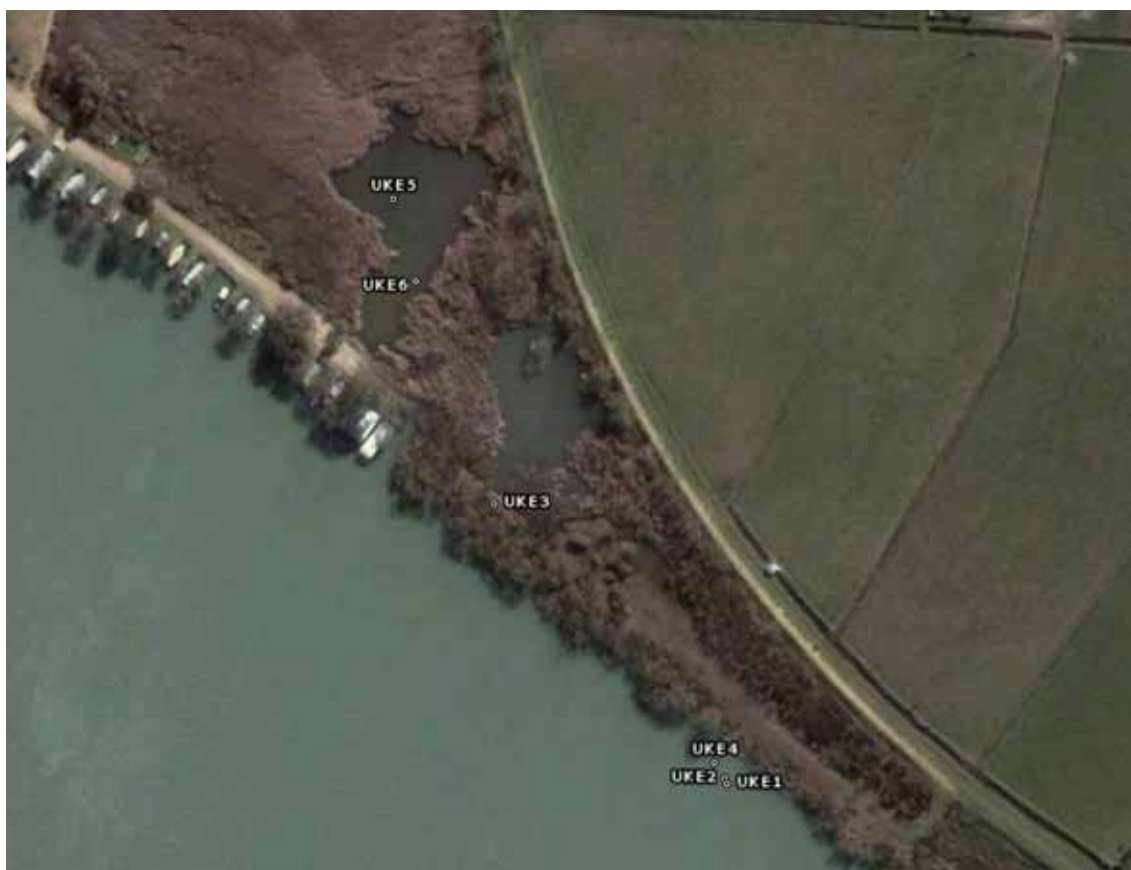
Figure 67. Ukee Boat Club and survey sites.

Ukee Boat Club (Figure 1) is an artificial wetland that is maintained behind a man-made levee, which is breached by narrow channels to maintain water levels in the wetland area behind. The wetland itself is small, being approximately 450 m at longest, and 100 m at widest (Figure 67). The wetland forms a complex of small lagoons connected by channels. Adjacent to the east the land is used for agriculture, to the north the wetland is bound by a paved road at the base of the small cliff (7 m). Willow trees line much of the river bank on the southern side of the wetland along the levee. An account of the habitat status is presented in Australian Water Environments (2008). At time of sampling the wetland was dry (Figure 68), and it was noted at the boat ramp river level gauge that the river level was -0.35 m AHD.

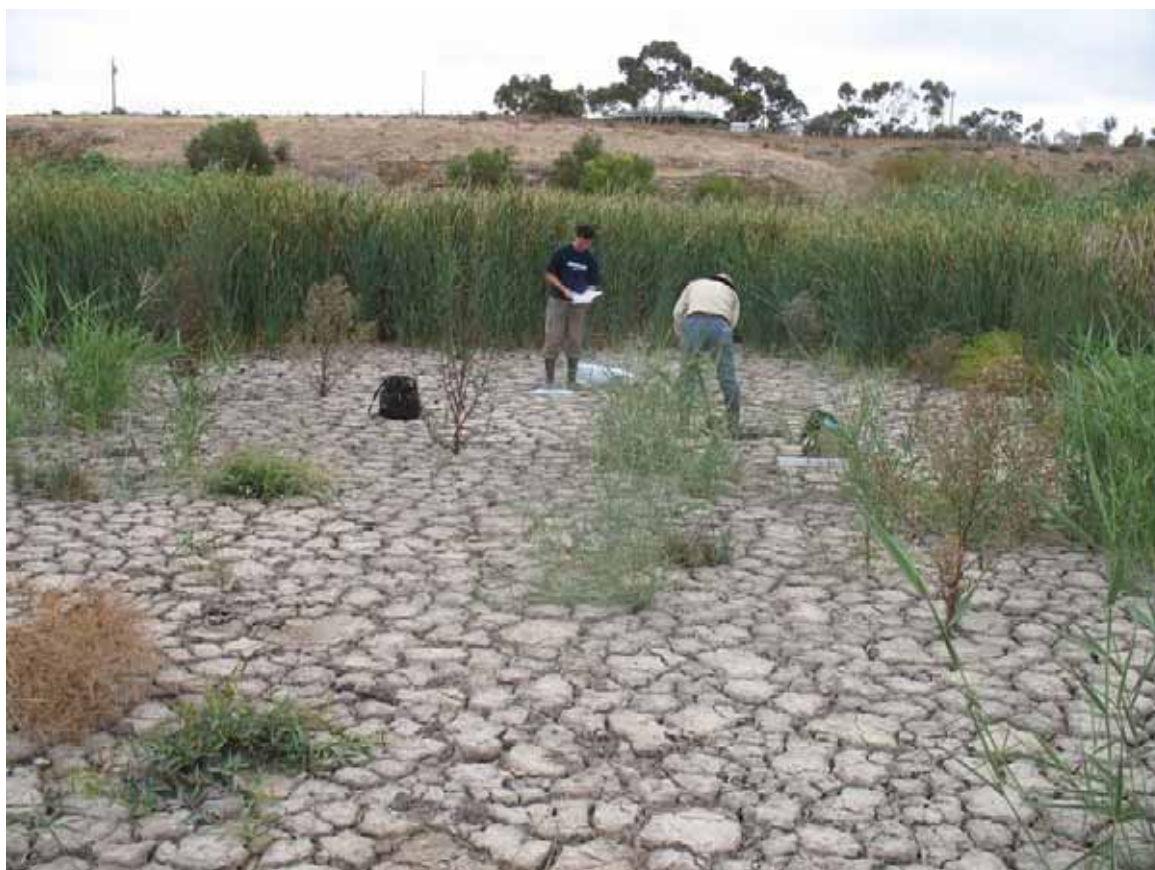
Figure 68. Landscape context of Ukee Boat Club wetland (see Figure 1).

UKE 1 (Figure 69) was taken from the river channel, 1 m off the bank (i.e. subaqueous ASS). UKE 2 (Figure 70) was taken in close proximity, from a profile recently disturbed by land moving. UKE 3 (Figure 71) was taken from the southern lagoon in a bare area that was being encroached by *Phragmites* and *Typha*. UKE 5 (Figure 73) was taken from the northern wetland, in the middle of the lagoon, while UKE 6 (Figure 74) was taken south of this. What was notable from the later two sampling sites was the large ped-size (e.g. 40 x 40 cm), and the wide (2 to 10 cm) and deep (50 cm and deeper) cracks that separated them (Figure 68).

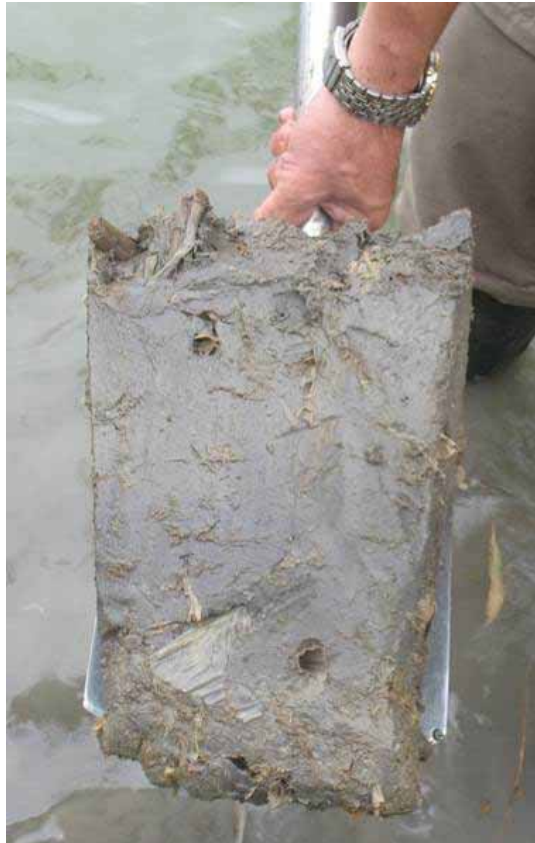
Figure 69. Photograph of profile UKE 1 sampled under water – i.e. subaqueous ASS (see Table 18 and Figure 2 for location).

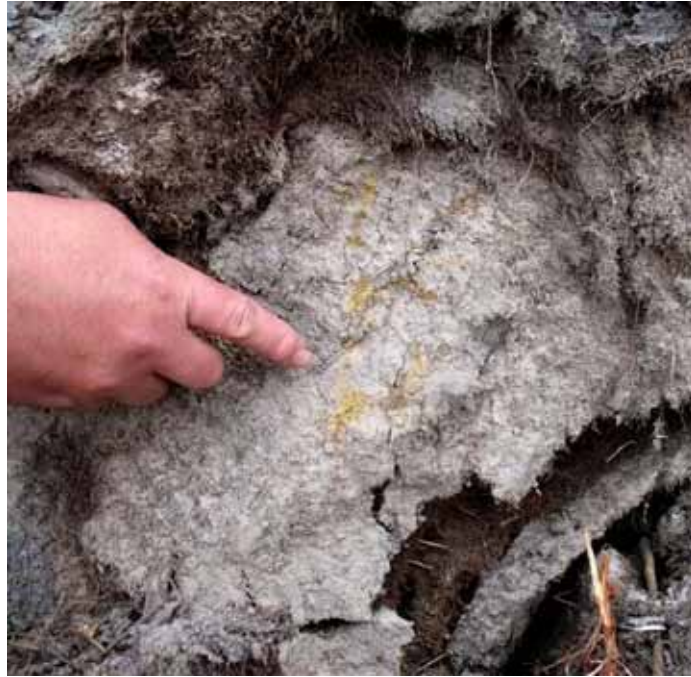
Figure 70. Photograph of profile UKE 2 from disturbed material on the bank showing bright yellow jarosite mottles (pH 3.9) (see Table 18 and Figure 2 for location).

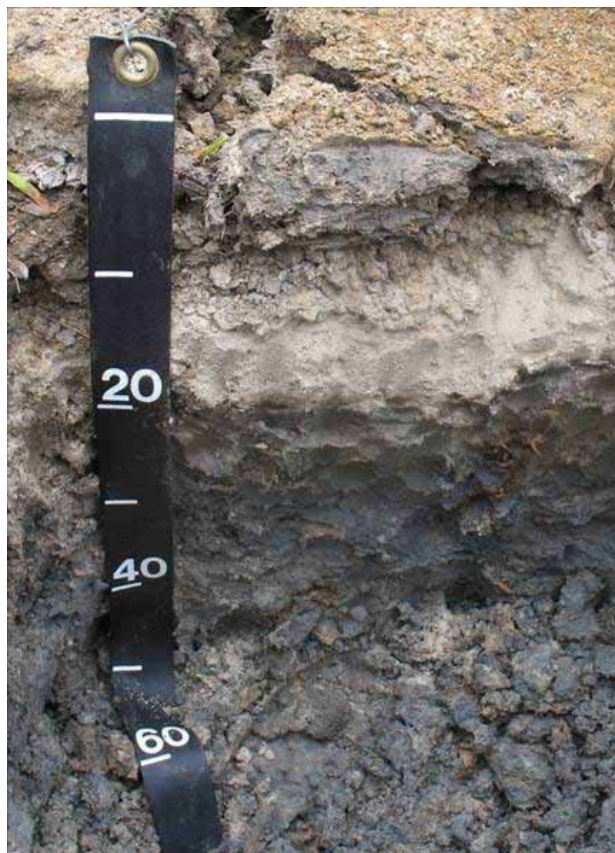
Figure 71. Photograph of profile number UKE 3 (see Table 18 and Figure 2 for location) showing bright yellow natrojarosite-rich, gypsum and hexahydrate salt efflorescences overlying sulfuric material in a cracked clayey-

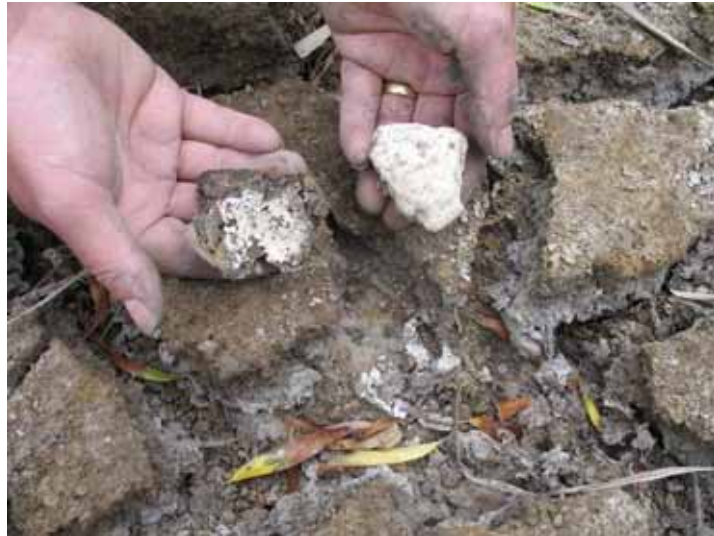
Figure 72. Photograph of jarosite mottling in sandy material similar to found in UKE 4 (see Table 18 and Figure 2 for location); NOTE – carbonate nodule and carbonate coatings on peds identified in cracks near profile UKE 3 (sample UKE 3.9 and UKE 3.10). Also showing bright yellow natrojarosite-rich, gypsum and hexahydrate salt efflorescences overlying sulfuric material in a cracked clayey-organic-rich ASS profile.

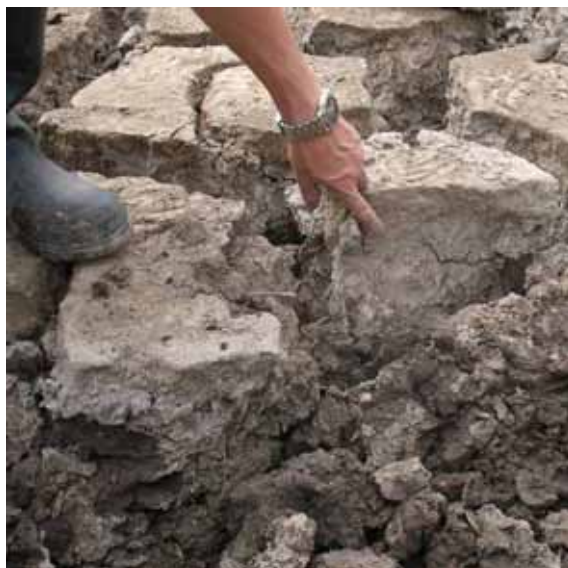
Figure 74. Photograph of profile number UKE 6 (see Table 18 and Figure 2 for location) - showing bright yellow natrojarosite-rich, gypsum and hexahydrate salt efflorescences overlying sulfuric material in racked clayey-organic-rich ASS profile

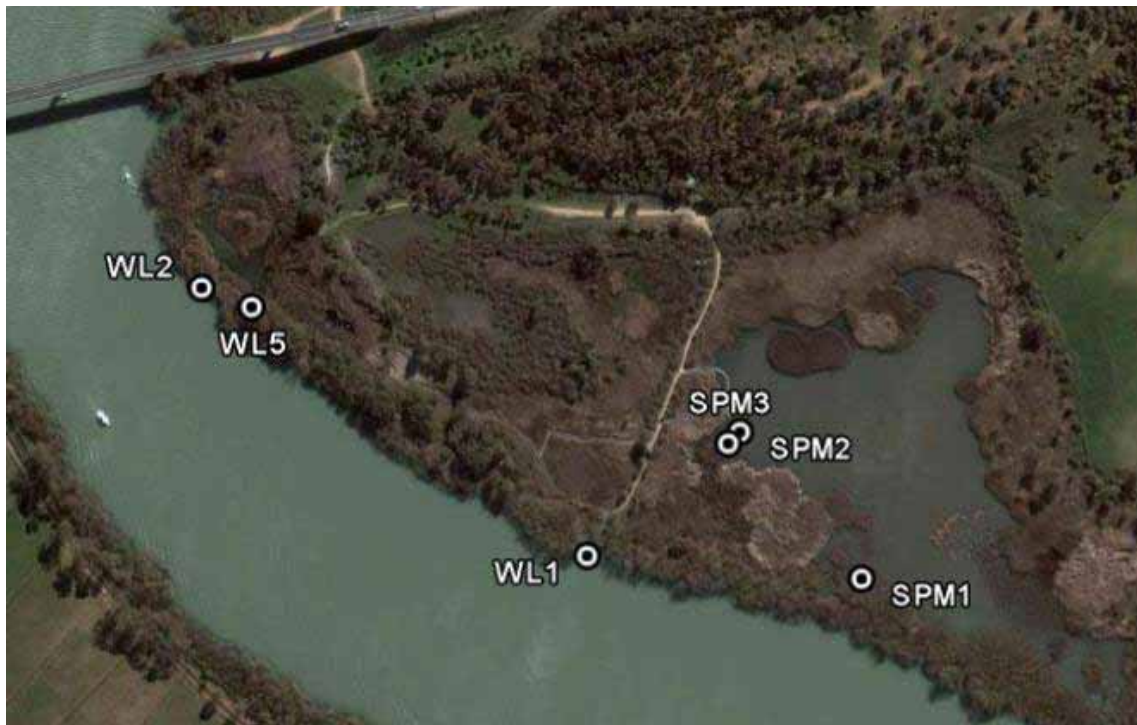
Figure 75. Swanport wetland and survey sites.

Swanport wetland (Figure 1) is a small wetland that is under community management, and is located immediately downstream of the Swanport Bridge (Figure 75). The wetland is located on the north bank of the river, and has a maximum length of 700 m and a width of 300 m. It features a complex of lagoons and reed beds (*Phragmites* and *Typha*).

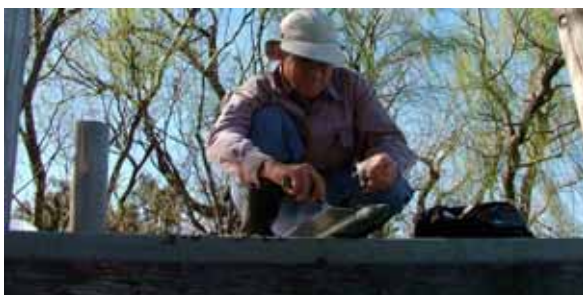
Site WL1 in the River Murray at the Swanport wetlands

Figure 78. Photograph showing sampling of the “Soft subaqueous sulfidic material”, using a Russian D-auger at profile number WL1 (see Table 18 and Figure 2 for location).

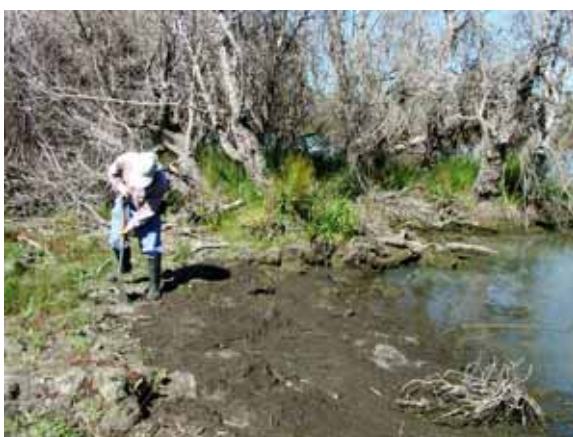
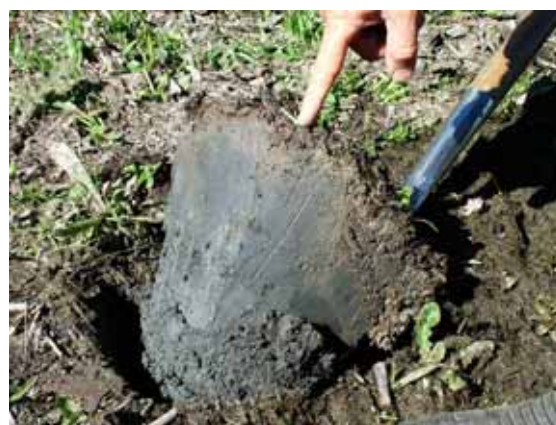
Site WL2 on the river bank a few hundred metres N of Site WL1

Sulfidic soil materials at Site WL2

Figure 79. Photograph of profile number WL 2 (see Table 18 and Figure 2 for location) showing sampling of “Soft poorly drained **sulfidic** soil” (left) and sulfidic materials sampled from Site WL2

| Method/<br>Sample | Depth | pH<br>water | pH <sub>Fox</sub> or<br>Peroxide | <sup>1</sup> ASS<br>materials | <sup>2</sup> ASS<br>classification<br>(and <sup>3</sup> code) | <sup>4</sup> S <sub>cr</sub> | <sup>5</sup> Lime<br>Calculation<br>kg CaCO <sub>3</sub><br>/tonne DW | <sup>6</sup> ASS<br>Risk |
|---|---|---|---|---|---|---|---|---|
| WL 2.1 | 0-5 | 7.15 | 2.13 | Sulfidic | Sulfidic<br>cracking clay<br>soil (3.2) | 0.046 | 3 | H |

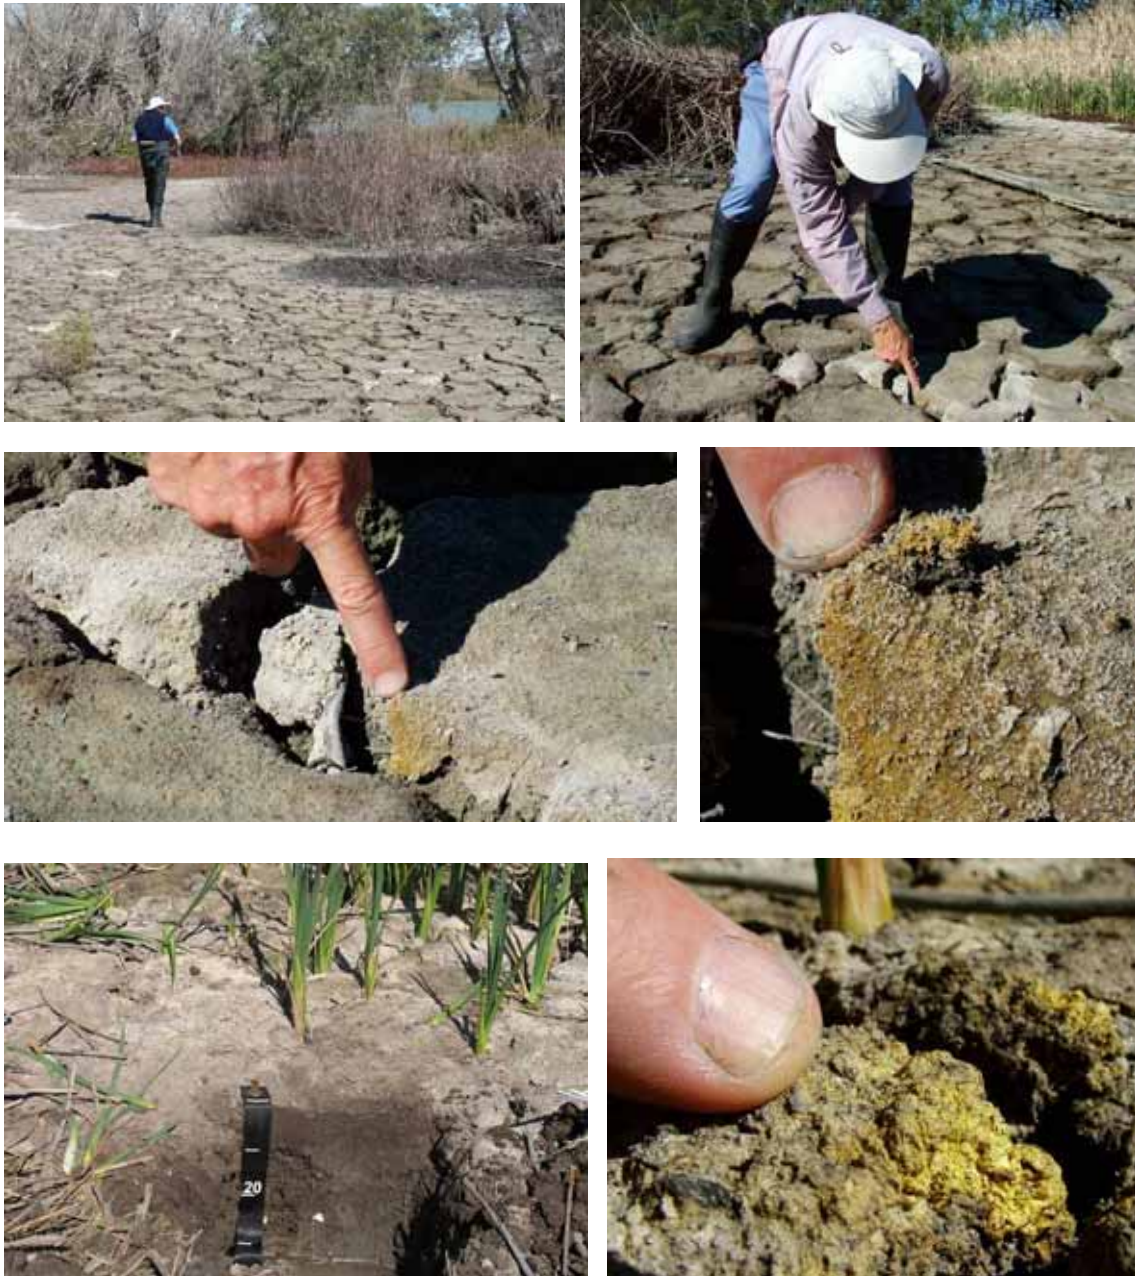
Figure 80. Photograph of profile number WL 5 (see Table 18 and Figure 2 for location) showing: 1: Acid Sulfate Soil with sulfuric material in drained wetlands adjacent to the River Murray (left), which shows extensive cracking and accumulation of scale-like, bright golden yellow crystals of metavoltine  $[K_2Na_6Fe^{2+}Fe^{3+}_6(SO_4)_{12}O_2 \cdot 18H_2O]$  and white crystals of alunogen  $[Al_2(SO_4)_3 \cdot 17H_2O]$ , which have formed as a result of aqueous, acidic ( $pH < 2.5$ ), sulfate bearing solutions that have percolated through the soil and attacked existing iron sulfides and layer silicates exposed in the cracks. These localised solutions were rich in ferrous and ferric iron and also contained leached potassium and sodium. Metavoltine and alunogen are presumed to be the last minerals to form. The sulfuric material, which also contains natrojarosite, hexahydrite and gypsum developed after drainage because watertable levels had dropped below 40 cm in June 2007 and below 90 cm in November 2007 - due to the severe drought conditions - exposing large sections of riverbank and wetlands that once contained high levels of un-oxidized iron sulfides (pyrite). Sulfidic material ( $pH > 4$ ), which contain un-oxidized pyrite, occurs below the water table shown (middle). (From Fitzpatrick *et al.* 2008a).

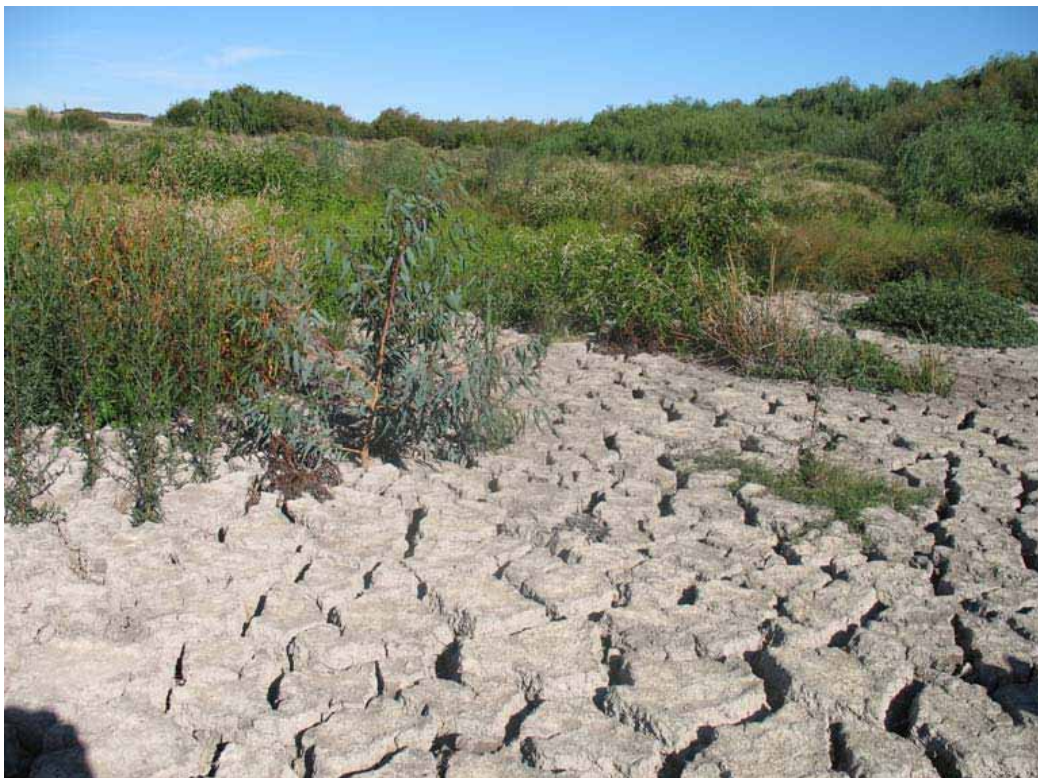
Figure 82. Photograph of site where profile numbers SPM 2 and SPM 3 were sampled (see Table 18 and Figure 2 for location) - showing sulfuric material in a clayey-organic-rich ASS (cracking clay soil) profile within the Swanport wetland.

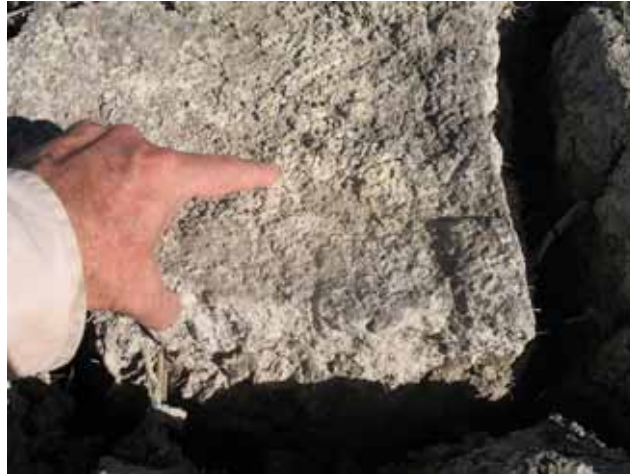
Figure 83. close-up photograph of profile number SPM 2 (see Table 18 and Figure 2 for location) showing bright yellow natrojarosite-rich, sideronatrite, gypsum and hexahydrate salt efflorescences overlying sulfuric material in a cracked clayey-organic-rich ASS profile within the Swanport wetland.

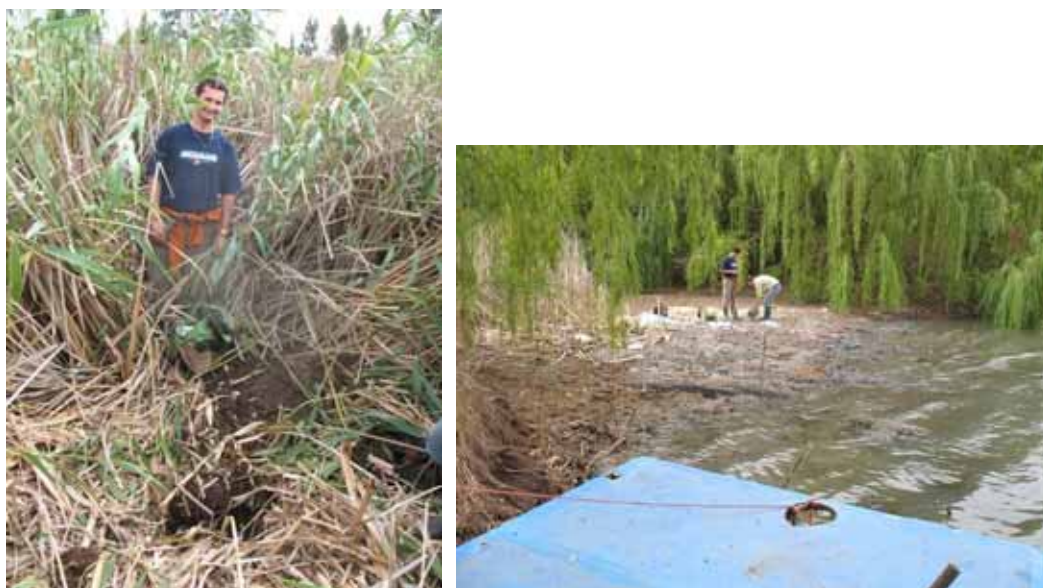
Figure 84. Landscape context of Murrundi wetland showing photographs of: (i) the dense stand of *Phragmites* at site MUR 1 (Photograph on Left Hand Side) and (ii) site MUR 2 is within the degraded stand of *Typha* to the extreme left of the two people and partially hidden by the overhanging willow branches on the left of the

photograph and approximately 20 m from the river edge, and (iii) site MUR 3 is in a subaqueous soil taken from a water depth of approximately 15 cm and located 5 m to the right of the two people (see Figure 1).
