# Acid sulfate soils in subaqueous, waterlogged and drained soil environments of nine wetlands below Blanchetown (Lock 1), South Australia: properties, genesis, risks and management

R.W. Fitzpatrick, P. Shand, M. Thomas, R.H. Merry, M.D. Raven and S.L. Simpson

Report prepared for South Australian Murray-Darling Basin Natural Resources Management Board

November 2008

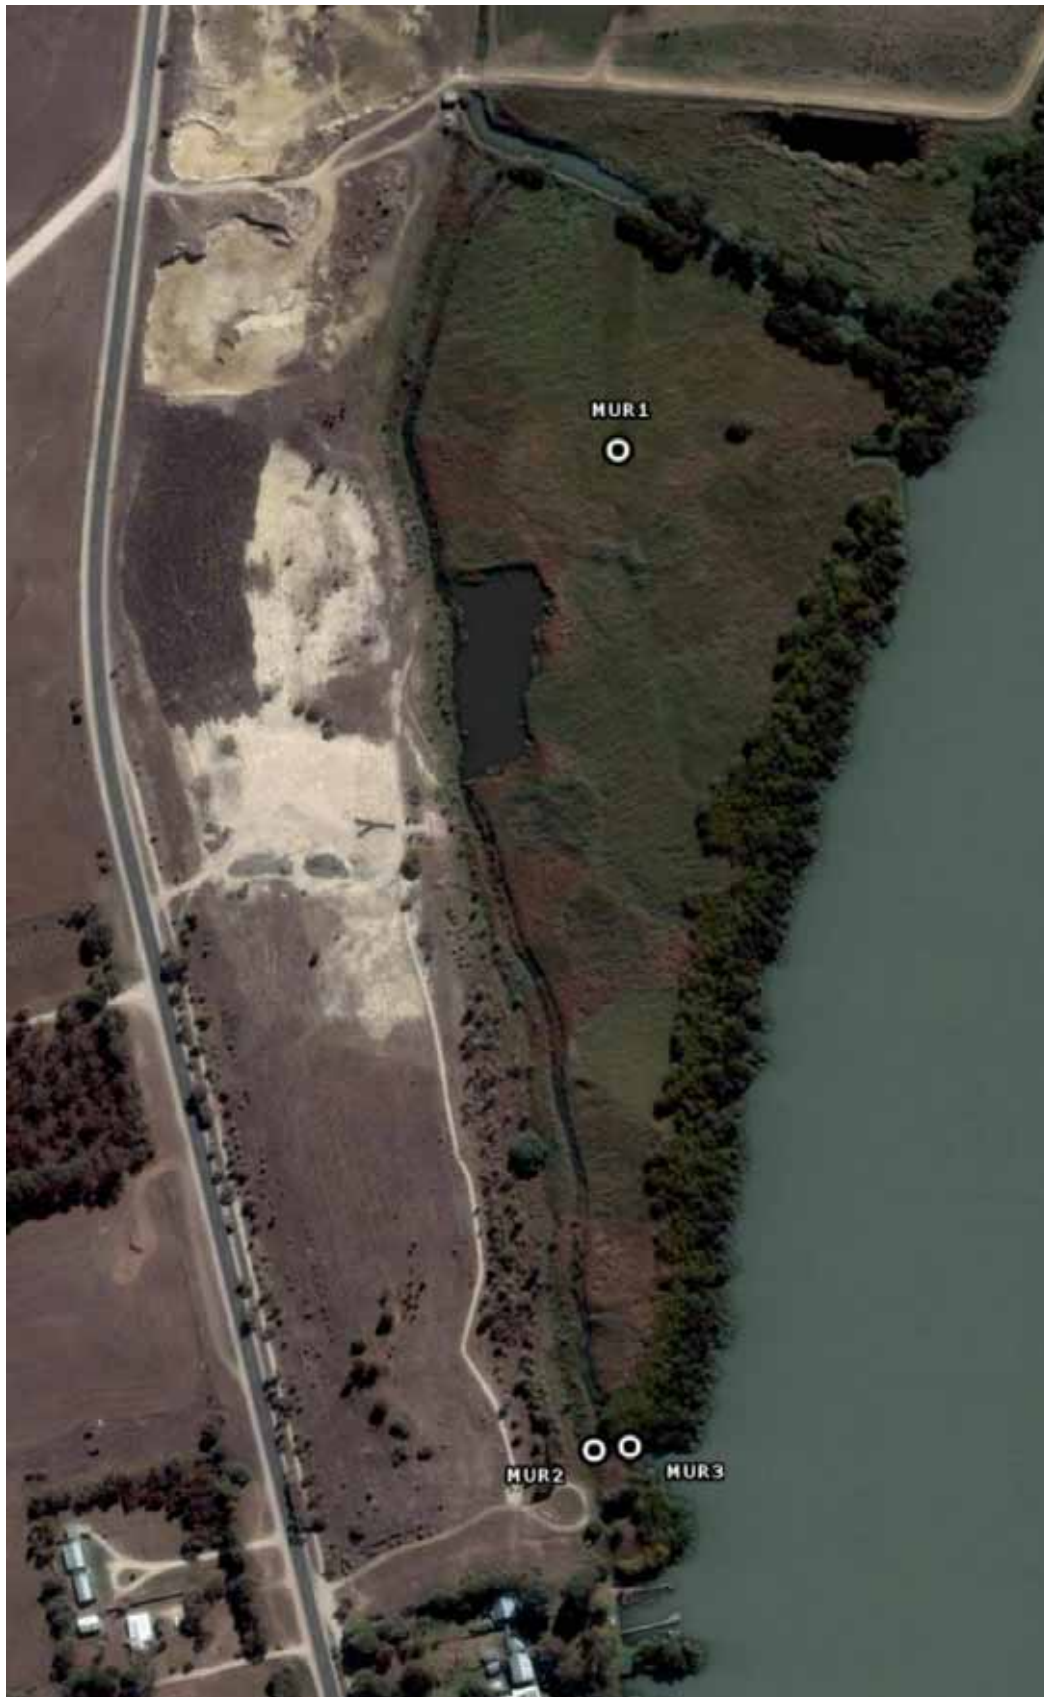
Figure 85. Murrundi wetland and survey sites.

The Murrundi wetland (Figure 2) is located on the western bank of the lower River Murray, within 5 km of the river's outflow into Lake Alexandrina. This is a small wetland, being 600 m at longest and 200 m at widest (Figure 85). According to Australian Water Environments (2008), the wetland is more terrestrial than riparian in nature as it does not act as a floodplain. To the east, the river bank is generally lined with willows, and the western edge/bank of the wetland is contained by a low gradient, eroded cliff, which has been modified by quarrying and other human activity. A full account of the habitat quality of the wetland is presented by Australian Water Environments (2008).

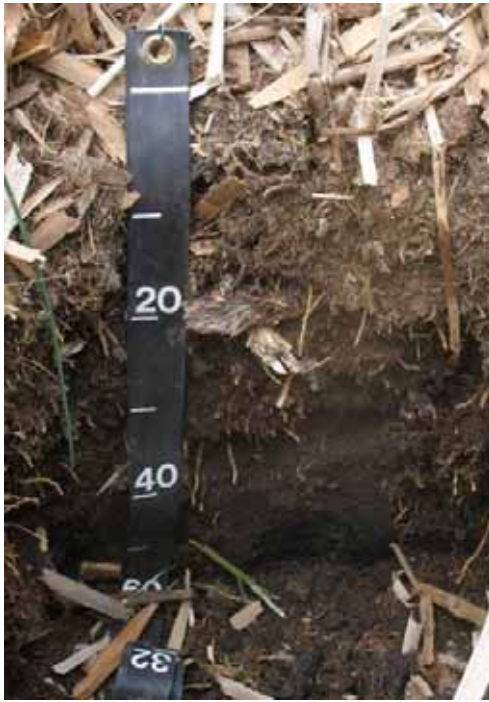
Figure 86. Photograph of profile number MUR 1 (see Table 18 and Figure 2 for location) showing organic-rich horizon

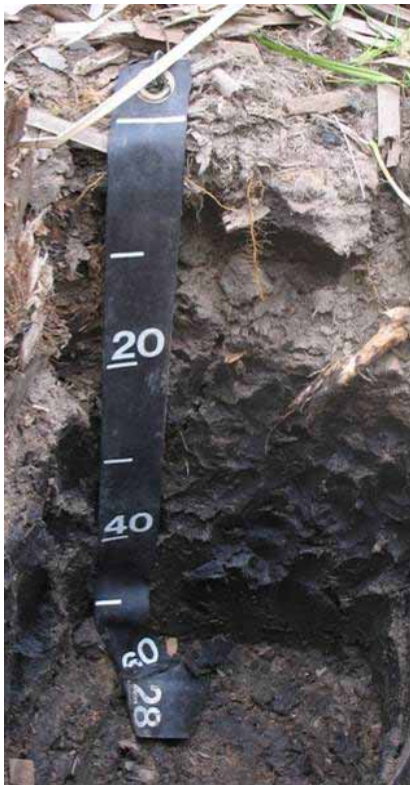
Figure 88. Photograph of profile number MUR 2 (see Table 18 and Figure 2 for location).

MUR 1 (Figure 86) was taken from the northern area of the wetland, approximately 100 m from the western bank, located in an extremely dense stand of *Typha*. MUR 2 (Figure 88) was taken from the southern end of the wetland, in a stand of *Phragmites*, and MUR 3 (Figure 91), approximately 20 m away from the river. This subaqueous soil was taken from a water depth of approximately 15 cm.

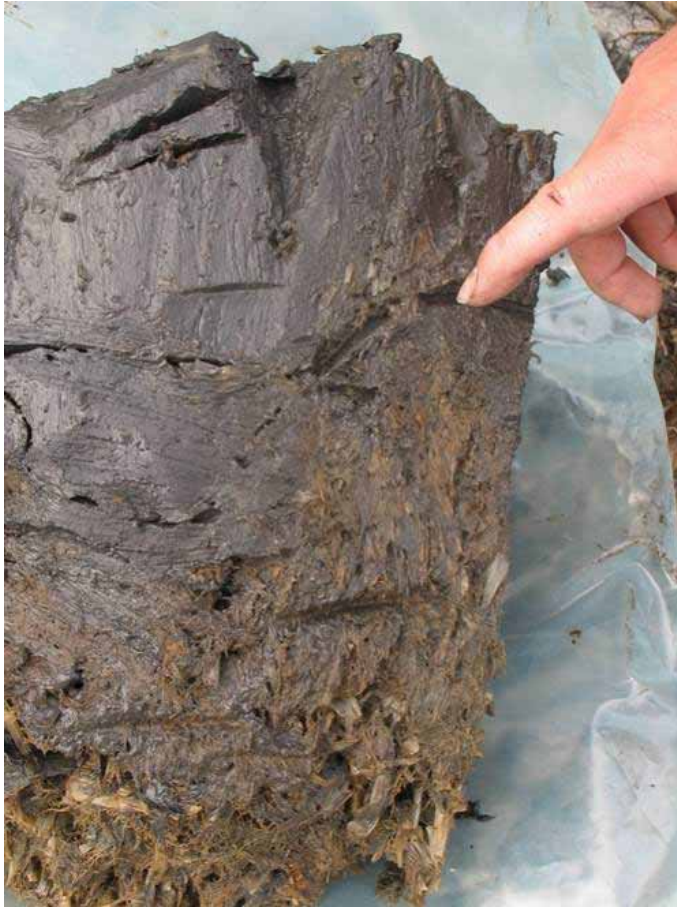
Figure 91. Photograph of profile number MUR 3, a Sulfidic subaqueous clayey soil (see Table 18 and Figure 2 for location, and Table 19 for morphological description).
