# A Successful HSCA Funded Cleanup:

## Karnish Instruments Site

Lock Haven, Clinton County, PA

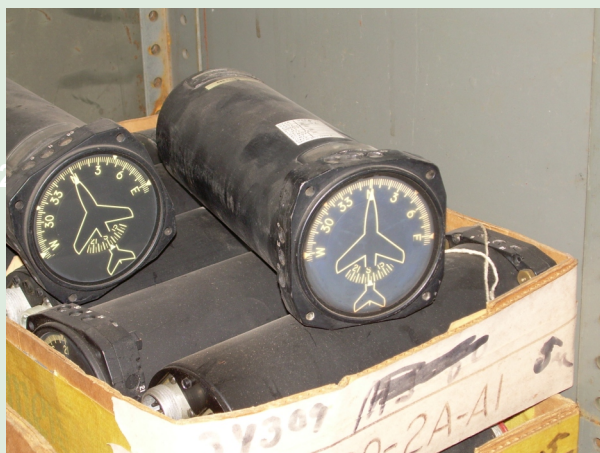
*Radium Illuminated Aircraft Gauge Dials*

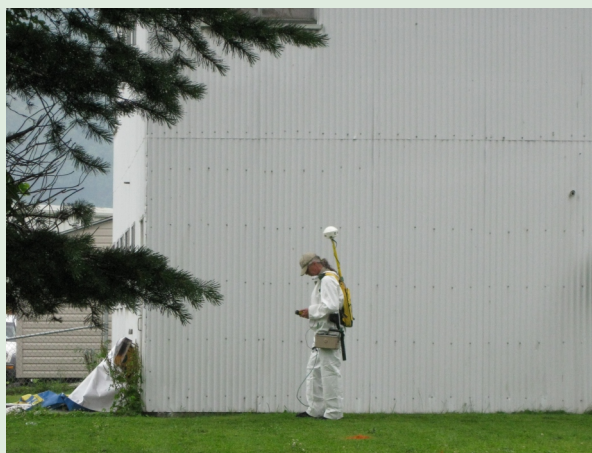
*DEP Surveying Radiation Contamination at the Former Keystone Instruments Site*

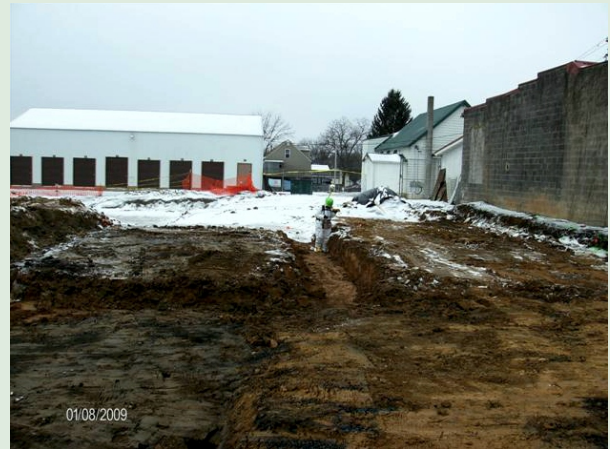
*Ron's Rental Excavation*

The cleanup of exterior areas at Ron's Rental and the five adjacent properties involved removing, packaging, and shipping the contaminated soil to a permitted and licensed out-of-state waste disposal site. Because the interior of the Ron's Rental building itself had been contaminated, that building was demolished, and building materials were also packaged and shipped to the disposal site.

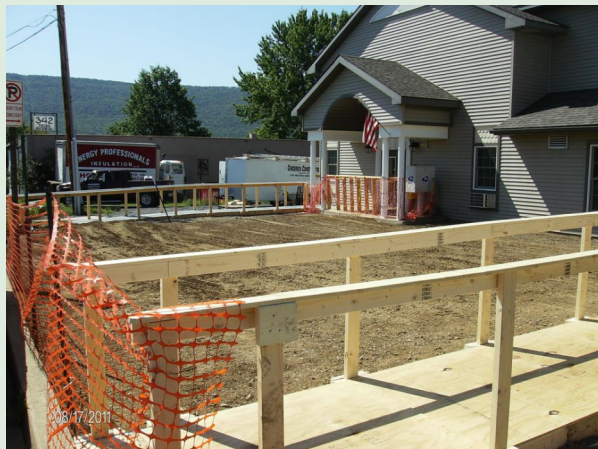
*Soil Removal at the Former Lock Haven Court Building*

In May 2018, the old Lock Haven Court apartment building was demolished. The debris, a concrete slab, and all contaminated soil remaining underneath were transported to a licensed disposal facility. The site was restored with backfill, topsoil, and grass seed and is now suitable for unrestricted use.

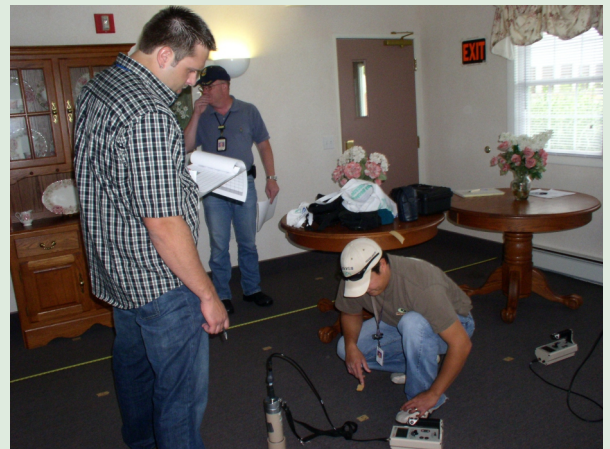
*DEP Radiation Survey Inside the Former Lock Haven Court Building*

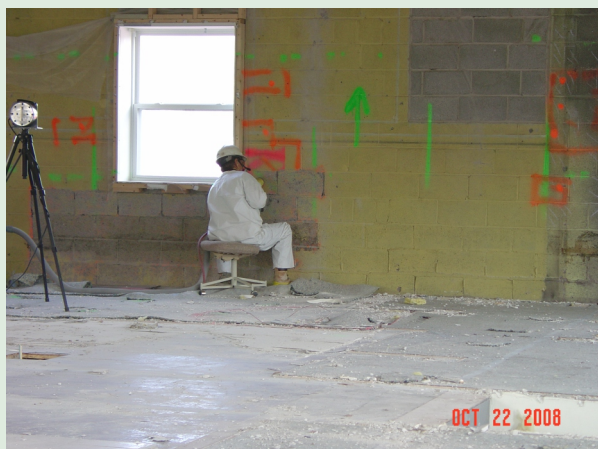
*Ron's Rental Interior Radiation Contamination Demolition*

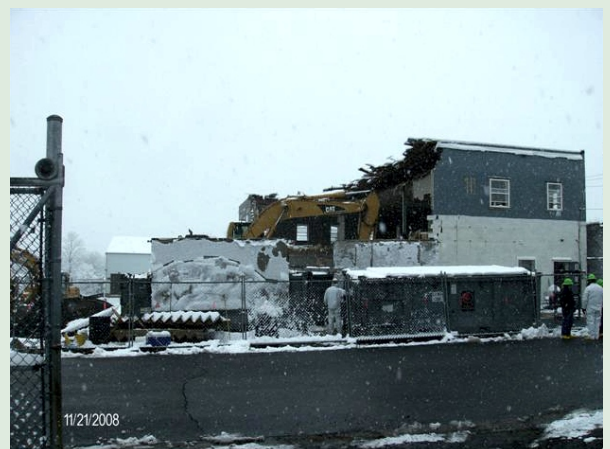
*Ron's Rental Demolition*

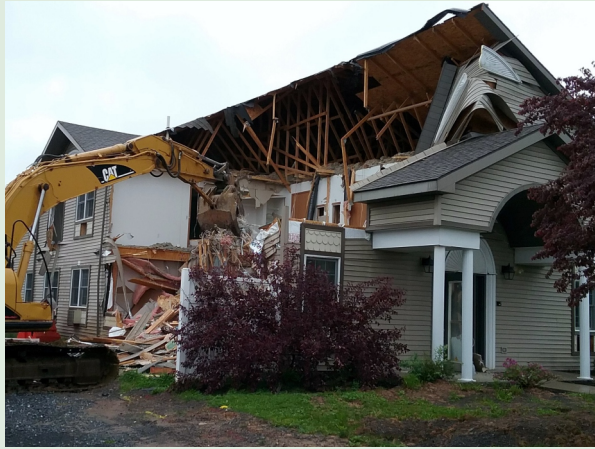
*Former Lock Haven Court Demolition*
